Chronological List of International High-rise Building Fire Incidents: 1986 - 2017

Unlikely to be fully comprehensive, none-the-less, the following chronological list identifies numerous serious and often fatal fire-spread incidents in high-rise properties, compiled from an 2017 on-line desk exercise, covering the period 1986-2017:

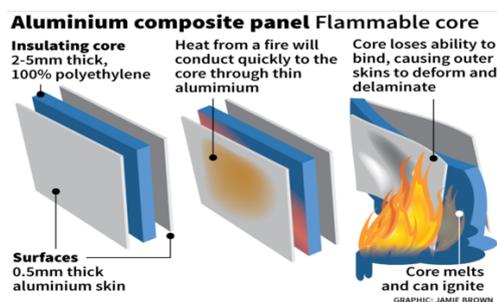
In 2014, a fire ripped through Melbourne's 23-storey Lacrosse Building, which turned out to be covered in non-compliant combustibile external cladding.

400 people were evacuated from the four-year-old building, with the city's fire brigade saying it was lucky nobody was killed. The cladding was blamed for the fire's rapid spread from the 8th floor to the top of the building. Now, the building's owners have launched a legal claim against the builders to cover the £10 million repair costs.

Australian buildings are cloaked in "millions of square metres" of flammable cladding, and authorities have been aware of the safety threat since at least 2010. In the wake of London's deadly tower fire, Fairfax Media can reveal the Australian Building Codes Board was told seven years ago that combustibile cladding was widely installed across the nation. An ongoing audit has identified at least 20 buildings in Melbourne with non-compliant cladding, including the Lacrosse apartments engulfed by a major fire in November 2014.
