Seeing What You are Looking At Unit 6 Learning Handbook

COTAC Insight 1: The Need to Appreciate the Built Heritage

Unit 6 Learning Handbook: Seeing What You Are Looking At

Council on Training in Architectural Conservation (COTAC)

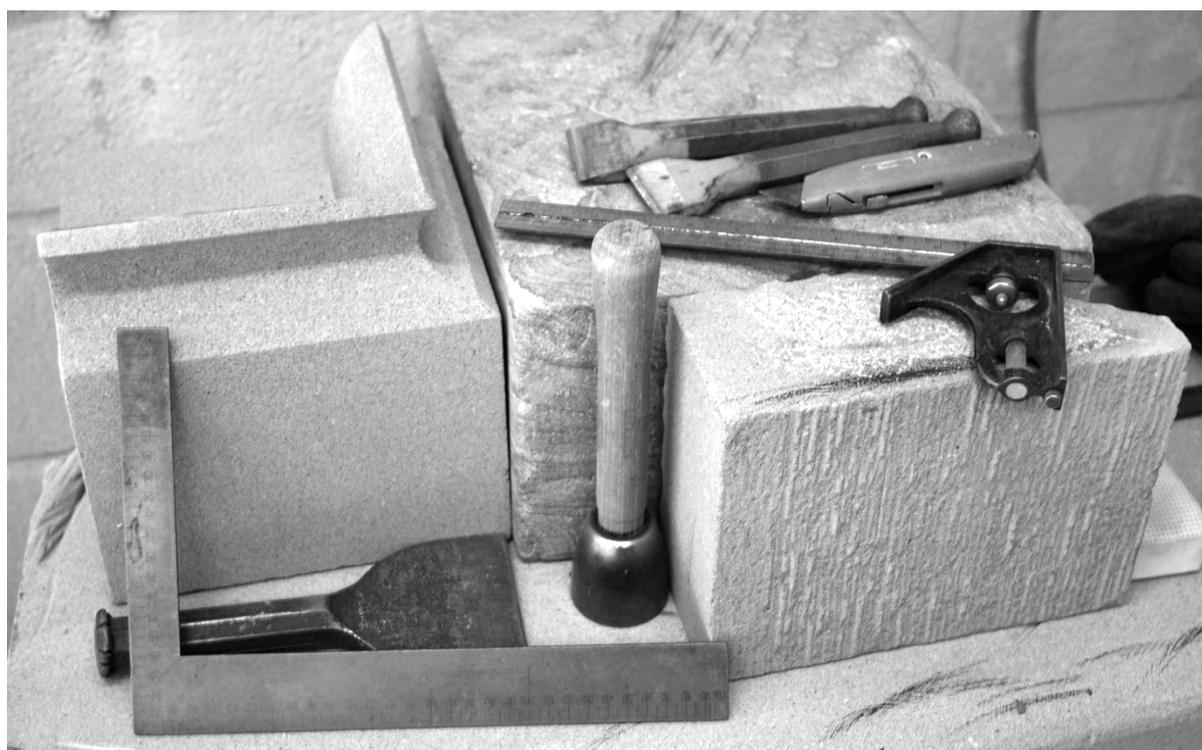
The construction of the built heritage has much relied upon the use of traditional craft skills. © Ingal Maxwell

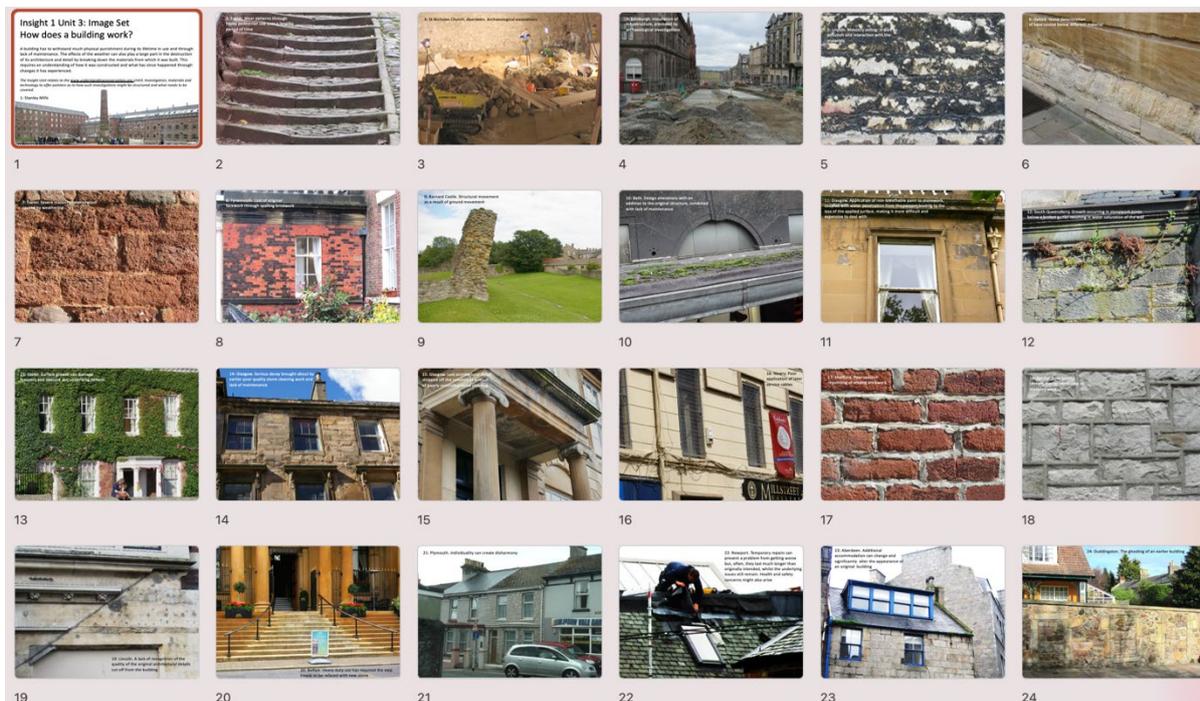
No.	Unit 3 Image Set: Caption Context	Additional Considerations
1	Stanley Mills: A variety of building shapes and sizes generally exist in association with each other	The variations of shapes relate to what the original purposes of each part was; this understanding is necessary to successfully plan for any work that might be required
2	Exeter: Even durable material surfaces can be worn away though repetitive use over time	The process of wear and tear can be increased and speeded-up by weathering and needs to be understood. If allowed to develop too far safety problems can arise
3	St Nicholas Church, Aberdeen: Whilst archaeological excavations seriously disrupt the ground by investigative digging, such excavations can be required for a number of reasons	To investigate and confirm what existed in the past in order to inform work in advance of building activities: Or where a location is under serious threat of being totally lost through natural and man-made causes: Or alongside a requirement for research and recording, Or by official direction.

4	Edinburgh: A number of issues need to be thought about before starting major road works in an urban setting	Safeguarding the general public, traffic disruption/re-direction, location of existing buried services, consideration of possible archaeology, disruption of building foundations
5	Lincoln: The 'blackening' of stone masonry wall surfaces can vary in intensity and with the type of stone used	Atmospheric pollution, rainwater run-off, and the behaviour of different stone types and their geology can all contribute to visual disturbance through discolouration. Limestone in particular reacts more with weather and pollution whilst sandstones can react to water penetration and interaction with the stone's mineral composition
6 *	Oxford: Due to a number of reasons significant erosion of stonework often occurs on the lower levels of wall Research consideration: Find out more about the effects of the wetting and drying cycle and what expertise might be required to explain the consequences	The stones might be wrongly cut and positioned. They may be subjected to excess wetting caused by 'splash-up'. The effects of frost action can be damaging and salts used to de-ice adjacent pavement surfaces can penetrate the stone and break it down. Harder more-durable stone built on top of less - durable block can increase water runoff and worsen the wetting and drying cycle

7 *	Exeter: With some types of sedimentary rocks (here a conglomerate), the stone blocks used for buildings can erode and lose their ashlar finished face as tooled by the original stone mason Research consideration: How many different forms of erosion might affect stonework on a building	Soft and poorly consolidated original stone can be susceptible to the effects of rain and sun through alternating of the drying and wetting process. The decay can result in a variety of effects and patterns which, depending upon their severity may require some stonework to be replaced. But often this is carried out unnecessarily when the remaining stone blocks can still carry their structural load – provided the visually eroded appearance is acceptable
8	Tynemouth: Brickwork that has failed can create a 'patchwork' effect of erosion	Some poor quality bricks result from under-fired clay losing their fired surface due to weathering. Ledges created by such erosion can increase further loss and decay by holding rainwater against the remnant bricks, where moss/lichen build-up and frost action can add to the difficulties

9	Barnard Castle: Structural distortion can be caused by a variety of issues resulting in walls leaning out of the vertical	Ground shrinkage and movement or land slip directly under or near heavy structural elements can affect the foundations causing them to rotate. Distortions can remain stable provided the 'middle-third rule' of stability remains intact, otherwise collapse is inevitable without temporary propping requiring advice from structural engineers

10	Bath: Later addition or alteration to an original building and its detail can be visually disruptive creating additional maintenance problems and may require to be researched to fully appreciate the issues involved	A wall is first constructed in length and thickness and in height building from the ground up. Later additions are often only applied to the flat wall face against which they are to be added. This approach requires the need to weatherproof the external junctions, frequently relying on the surface application of a mastic sealant to stop rainwater penetration
11	Glasgow: The application of a non-breathing 'plastic-based' paint coverings to wall surfaces with the mistaken belief that it can protect the structure against weather can become a significant error	Whilst it might be realistic to accept assurances that such a covering can prevent water from getting into the structure, it can also equally and significantly prevent water in the structure from getting out! Consequently when the bond between the paint and the wall surface fails due to moisture penetration from faulty maintenance elsewhere, the paint blisters and peels off creating a greater problem to solve

12	South Queensferry: If an excess of moisture is allowed to continue to saturate the structure of a wall, its lime mortar can be the first element to decay. Analysis of the original mortar may be required	Such persistent sources of water can come from faulty parapets, broken or leaking gutters and downpipes or overflows. Erosion of mortar joints and beds and the loss of loose mortar provided ledges for moss to grow and the deposition of seeds and penetrating roots, followed by more established plant growth
13	Exeter: Wall climbing plants growing on buildings to such an extent as this might look attractive to some but, if it were Ivy, greater and potentially costly concerns can be raised	Ivy uses tendrils to attach to a surface and will seek vulnerable areas such as soft mortar joints to which they can attach. In doing so damage to the joints will occur. Ivy can also hold moisture against/in the wall altering its ability to perform and leading to decay. Once established Ivy tendrils are difficult to remove, dislodging masonry and penetrating deeply into the heart of the wall

14 *	Glasgow: An extremely bad, but revealing, example of the consequences of using an inappropriate stone cleaning technique, coupled with cement mortar patch repairs on an ashlar sandstone building Research consideration: Why is stone cleaning a sandstone building more of a problem than cleaning a limestone one?	Aggressive physical and chemical stone cleaning techniques can completely remove the outer surface patina of sandstone to expose the interior of the stone block increasing weathering and decay. Patching areas of walling with a thin, hard, cement-based plaster, lined on the surface to copy the underlying shape of the stones, only adds to the problems. This approach traps rainwater behind the cement work, increasing the rate and degree of erosion of the underlying stone. The thin and, usually, sharp-edged cement

patches quickly fail and detach to fall off the wall face creating a safety issue for passers-by
15	Glasgow: A poor and excessively abrasive stone cleaning method has damaged the original detailing of these Ionic fluted columns. Consideration may be required to establish the original appearance	The original projecting fluted detailing of the columns has been cut off, reducing their profiles to only shadows or 'ghost' lines of the original fluting. The edges of the large lintol have also been damaged. The short lintol on the left has been replaced with new moulded stone
16	Newry: Uncontrolled, cheaply installed and poorly secured electric, telephone, cable TV supplies and junction boxes on the building exterior. Redundant cables are often left furthering poor visual appearance	Poorly introduced cable runs and associated mechanical fixings, security grilles to windows, advertising banners and signs combine to create a seriously detracting visual impact. Mechanical damage to the stonework from fixing methods are permanently disfiguring and will remain long after cabling has become redundant.

17	Sheffield: Poorly applied hard cement-based mortar pointing shows a lack of skills training and understanding	The walling, constructed of soft red-clay bricks, is susceptible to a high degree of erosion. The effect of using a non-breathable and hard cement mortar to re-point the wall, instead of a more traditional lime mortar mix, will increase the rate of erosion by trapping rainwater behind the cement work
18	Kendal: A form of applied cement-based 'strap' pointing had been adopted in the re-pointing of this masonry	The technique is likely to cause long-term erosion as the hard mortar is subject to a high degree of shrinkage cracking. This can lead to rain water being caught on the upper surface of each joint then running into the body of the wall, through shrinkage cracks. The use of 'strap' re-pointing is also visually detracting although, in some areas of the country, it is the traditional way of working

19	Lincoln: The original moulded stone detailing is missing on the right where it has been roughly chiselled off leaving ugly scars	A groove has been cut at an angle across stonework into which a membrane had been inserted to create a weathertight junction for an addition that has since been removed. The glued on spikes are to prevent birds from roosting
20	Belfast: The main section of the entrance steps have been re-surfaced with access path defined and limited by the handrailing	The treads have been reduced in thickness and thin slabs have been inserted. The sections of steps beyond the handrails are untouched and un-used because of the blocking infill work between the columns

21	Plymouth: Unsympathetic changes detract from the original detailing and harmony of these terraced houses	Modern tiles have been used in one re-roofing exercise; the original terracotta ridge has been lost in one. Different designs of plastic windows and doors have replaced the original timber windows and door details. False stone 'cladding' has been added to one house. Plastic rainwater goods have replaced the original (probably) cast iron. The shape of the window openings have been changed. Pavement side railings and gates have been changed/lost.
22	Newport: Health and Safety concerns emerge due to the method of working	No personal protection used – high visibility clothing, hard hat etc and especially no safety harness whilst working from height. Lead is a hazardous material and there appears to be no safety precautions adopted about handling it.
23	Aberdeen: Evidence of increased accommodation needs, coupled with a lack of basic and poor maintenance?	The wider dormer mullion was required to accommodate the thickness of an internal room partition in the attic. Grass growing in the guttering has not been cleared risking rainwater discharging into the building. Timberwork of lower window frames has not been subject to regular re-painting. Some stonework joints are eroded and need re-pointing

24	Duddingston: Reading the patterns on a wall face can be revealing about the past	The three blocked-up areas have once been a door and two windows of an external wall of a house, since demolished. A series of flat coping stone have been added to protect the remaining wall structure from the weather. The pavement level has been regraded

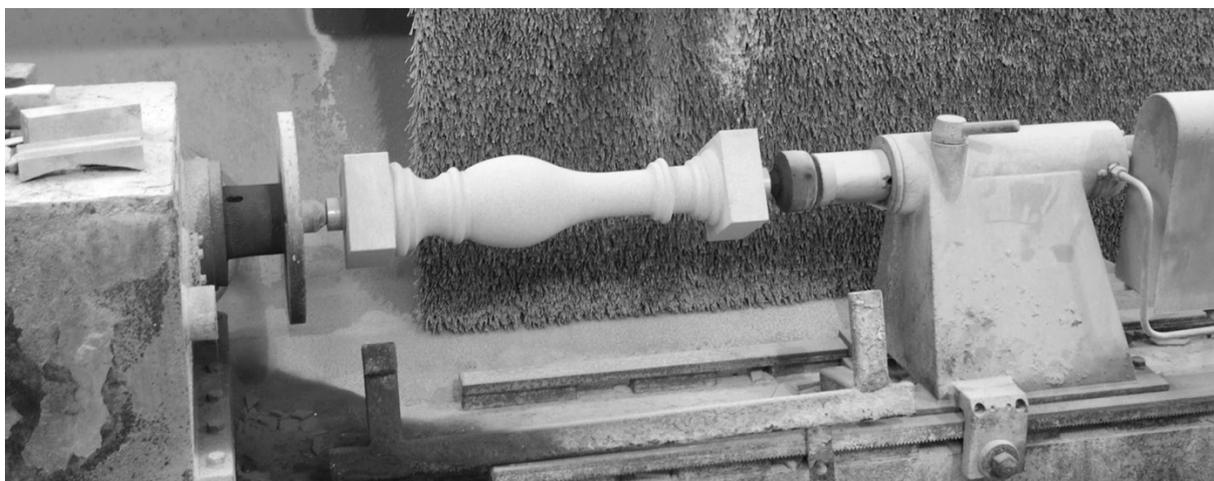
Skilled operations when working in stone and timber have many parallels. © Ingval Maxwell
