Insight 1 Unit 3: Image Set

How does a building work?

The Insight Unit relates to the www.understandingconservation.org Unit3: Investigation, materials and technology to offer pointers as to how such investigations might be structured and what needs to be covered.

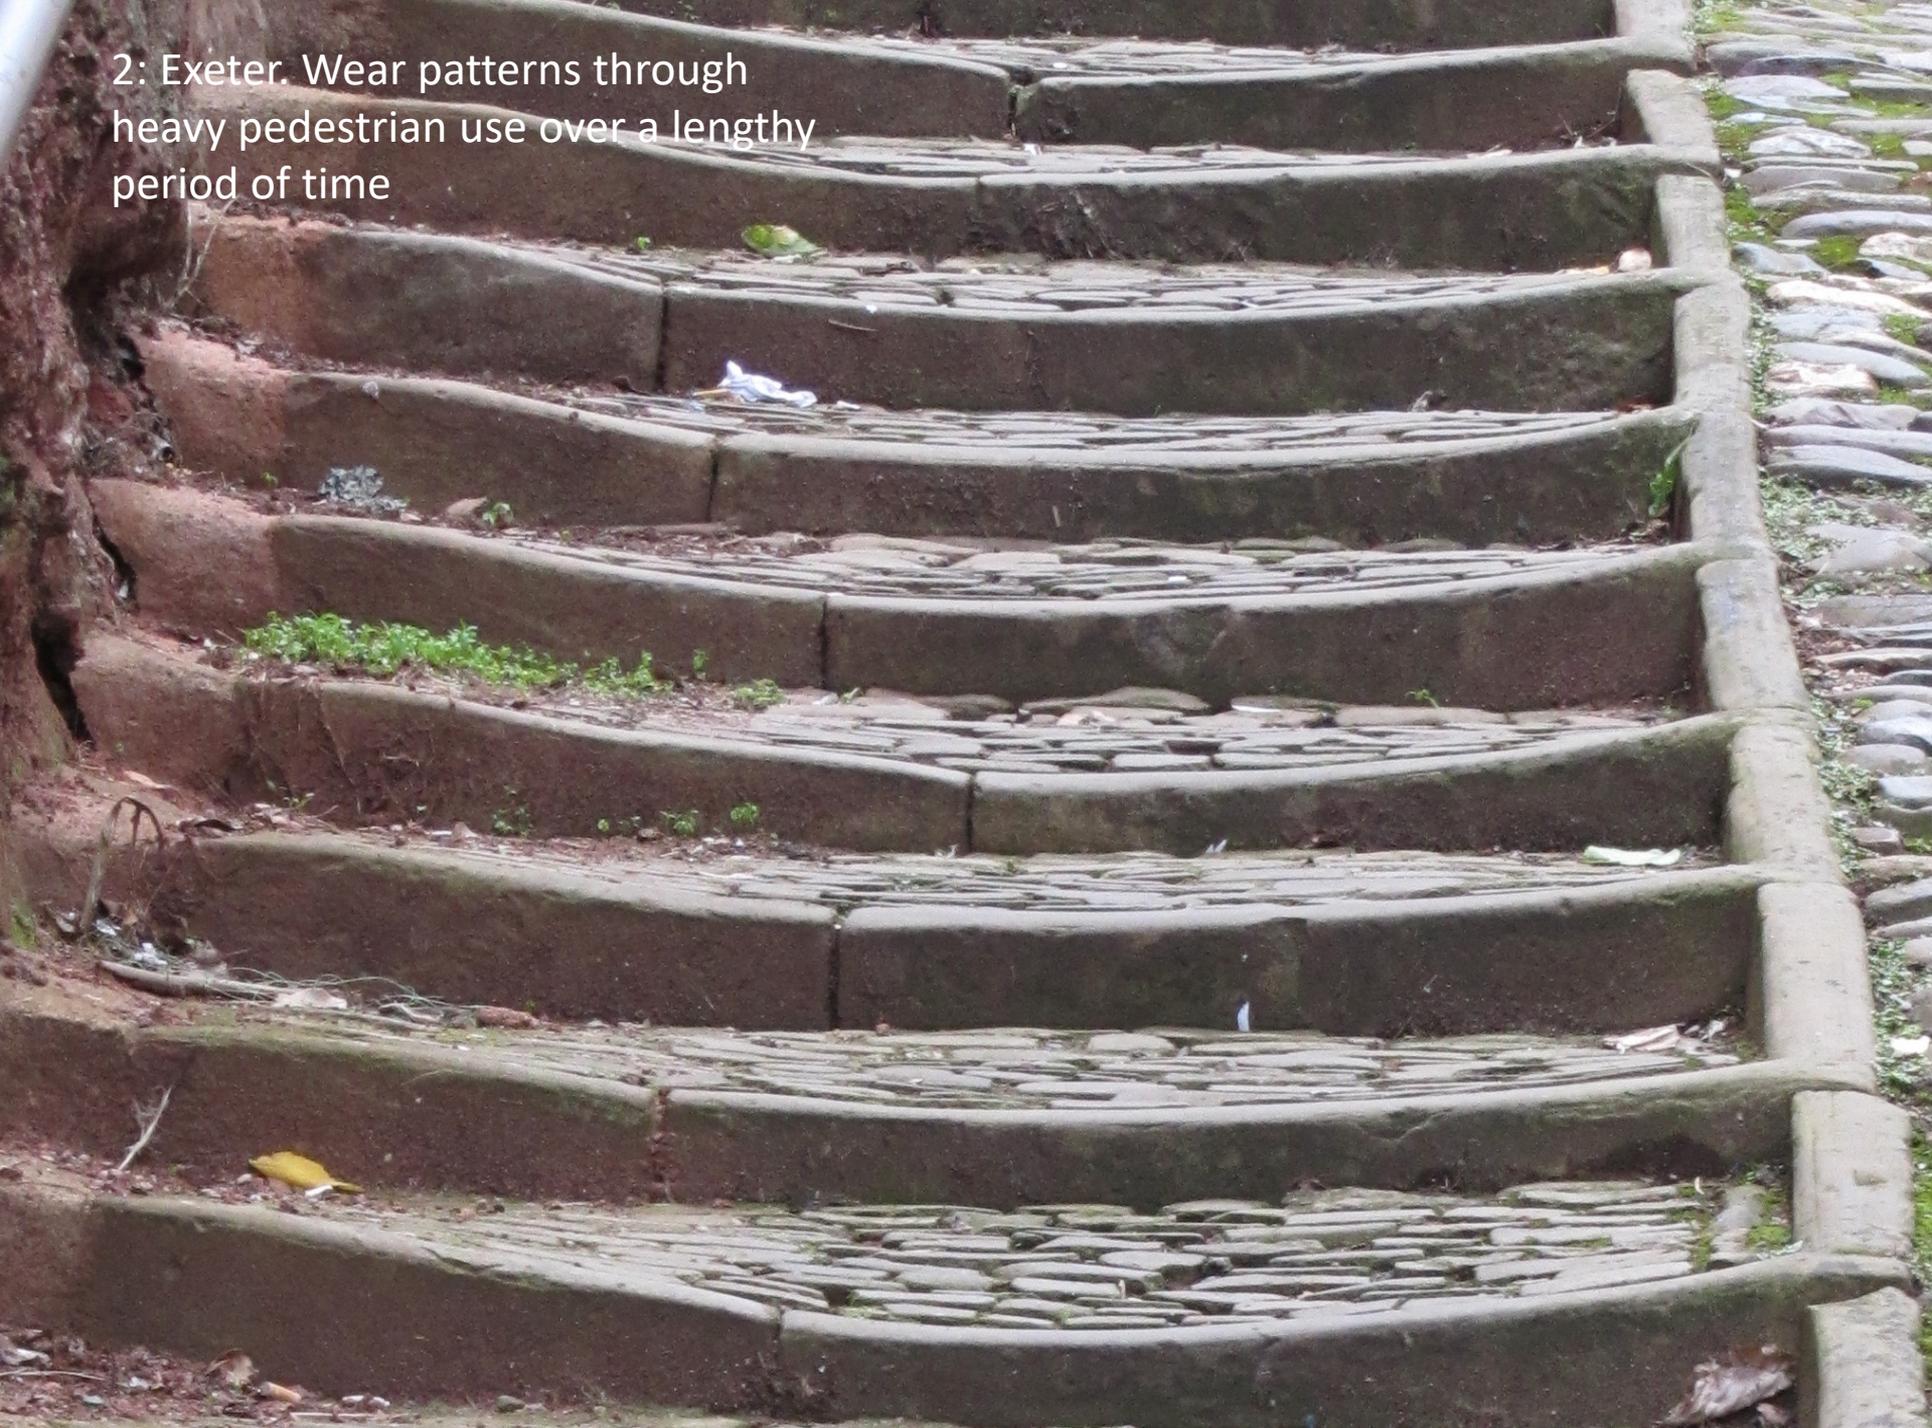
2: Exeter. Wear patterns through heavy pedestrian use over a lengthy period of time

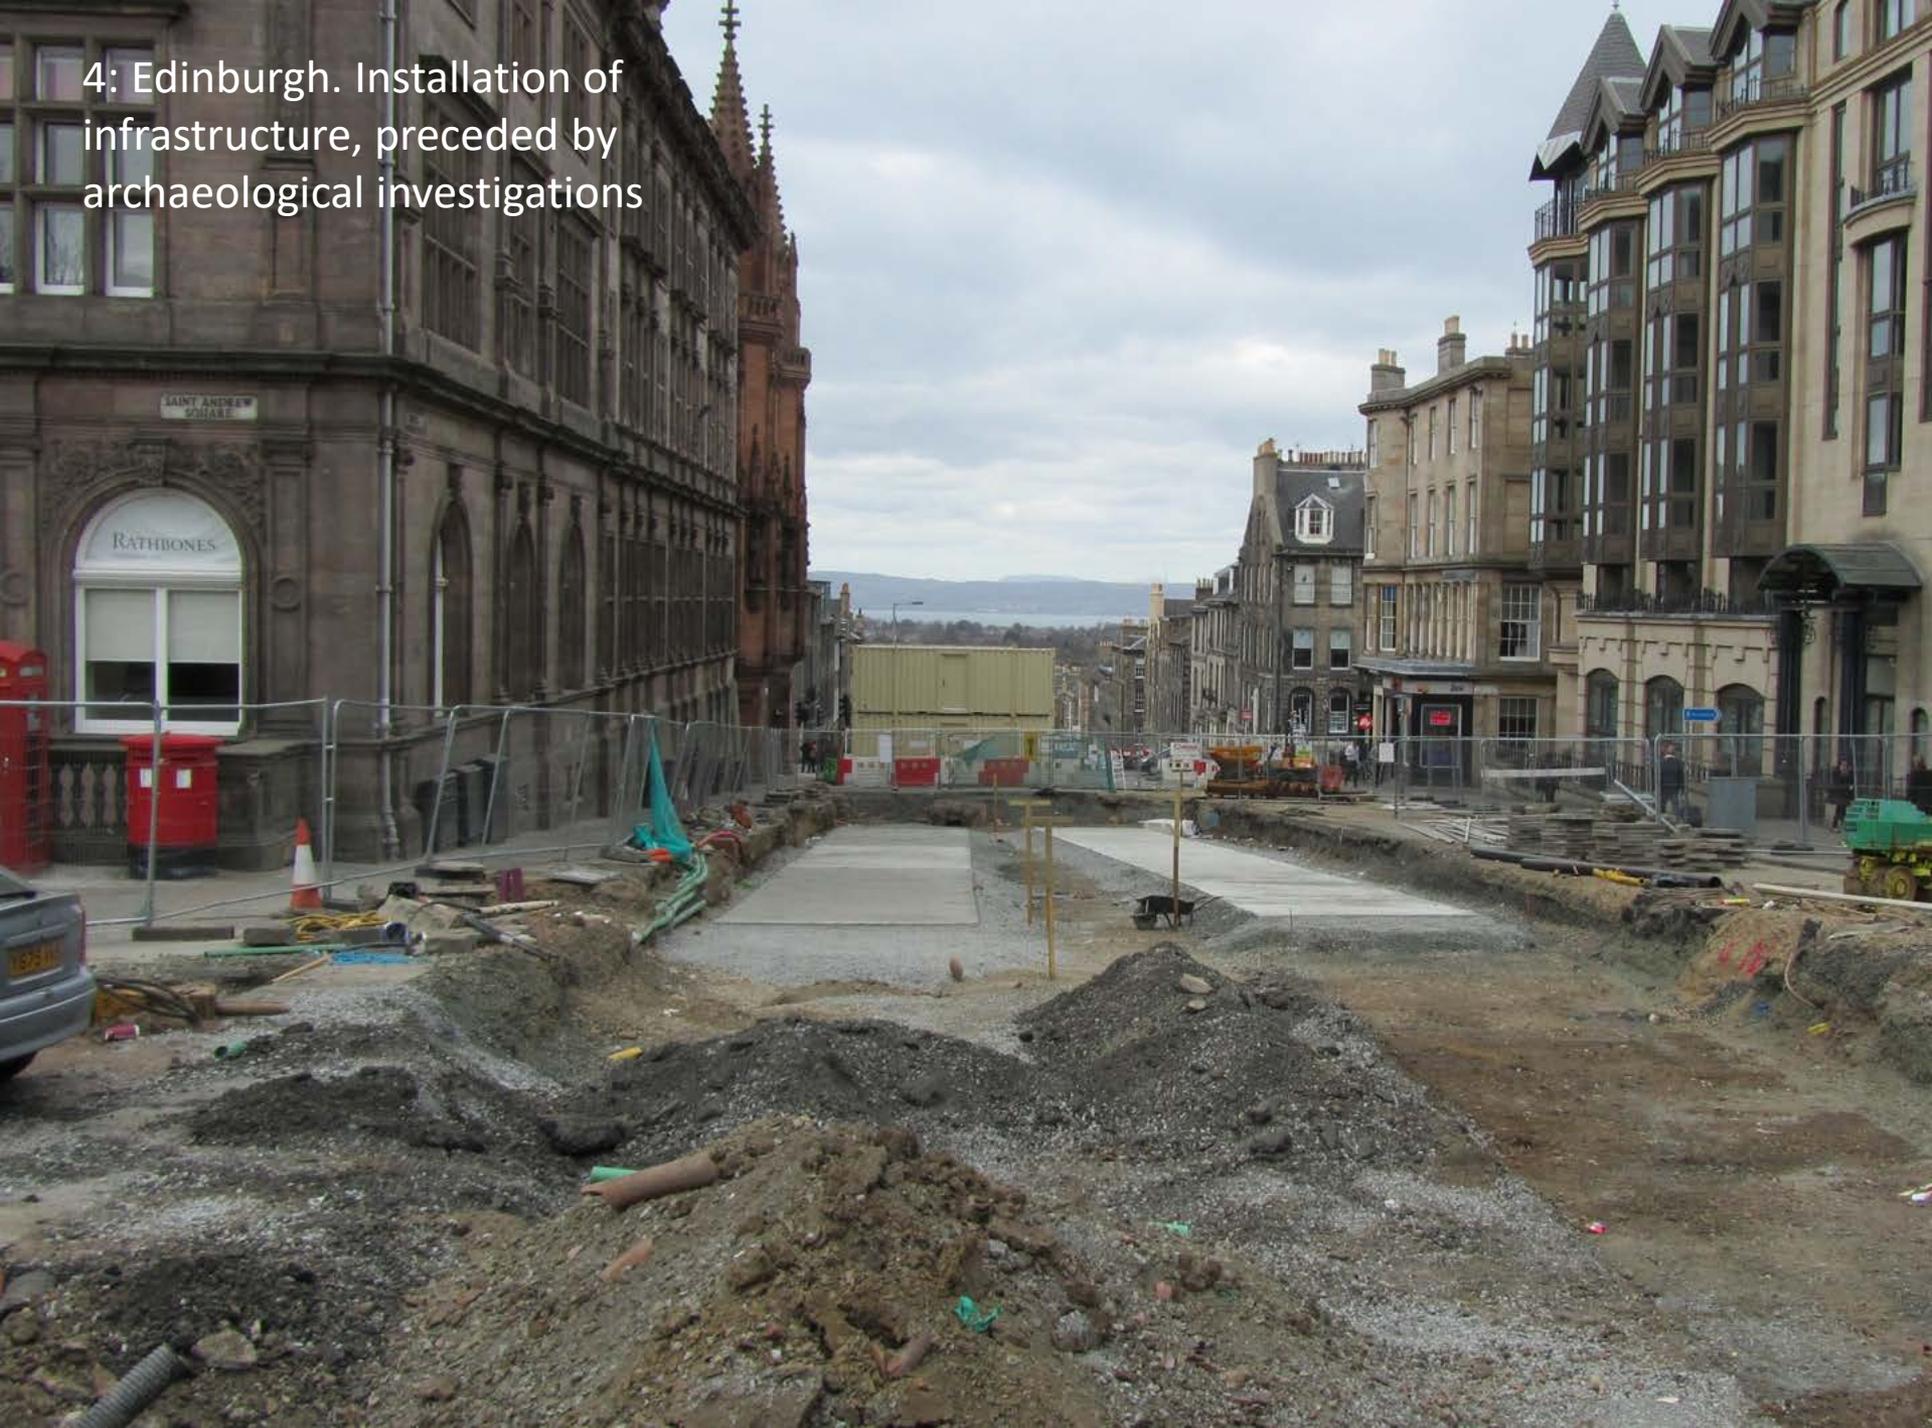
4: Edinburgh. Installation of infrastructure, preceded by archaeological investigations

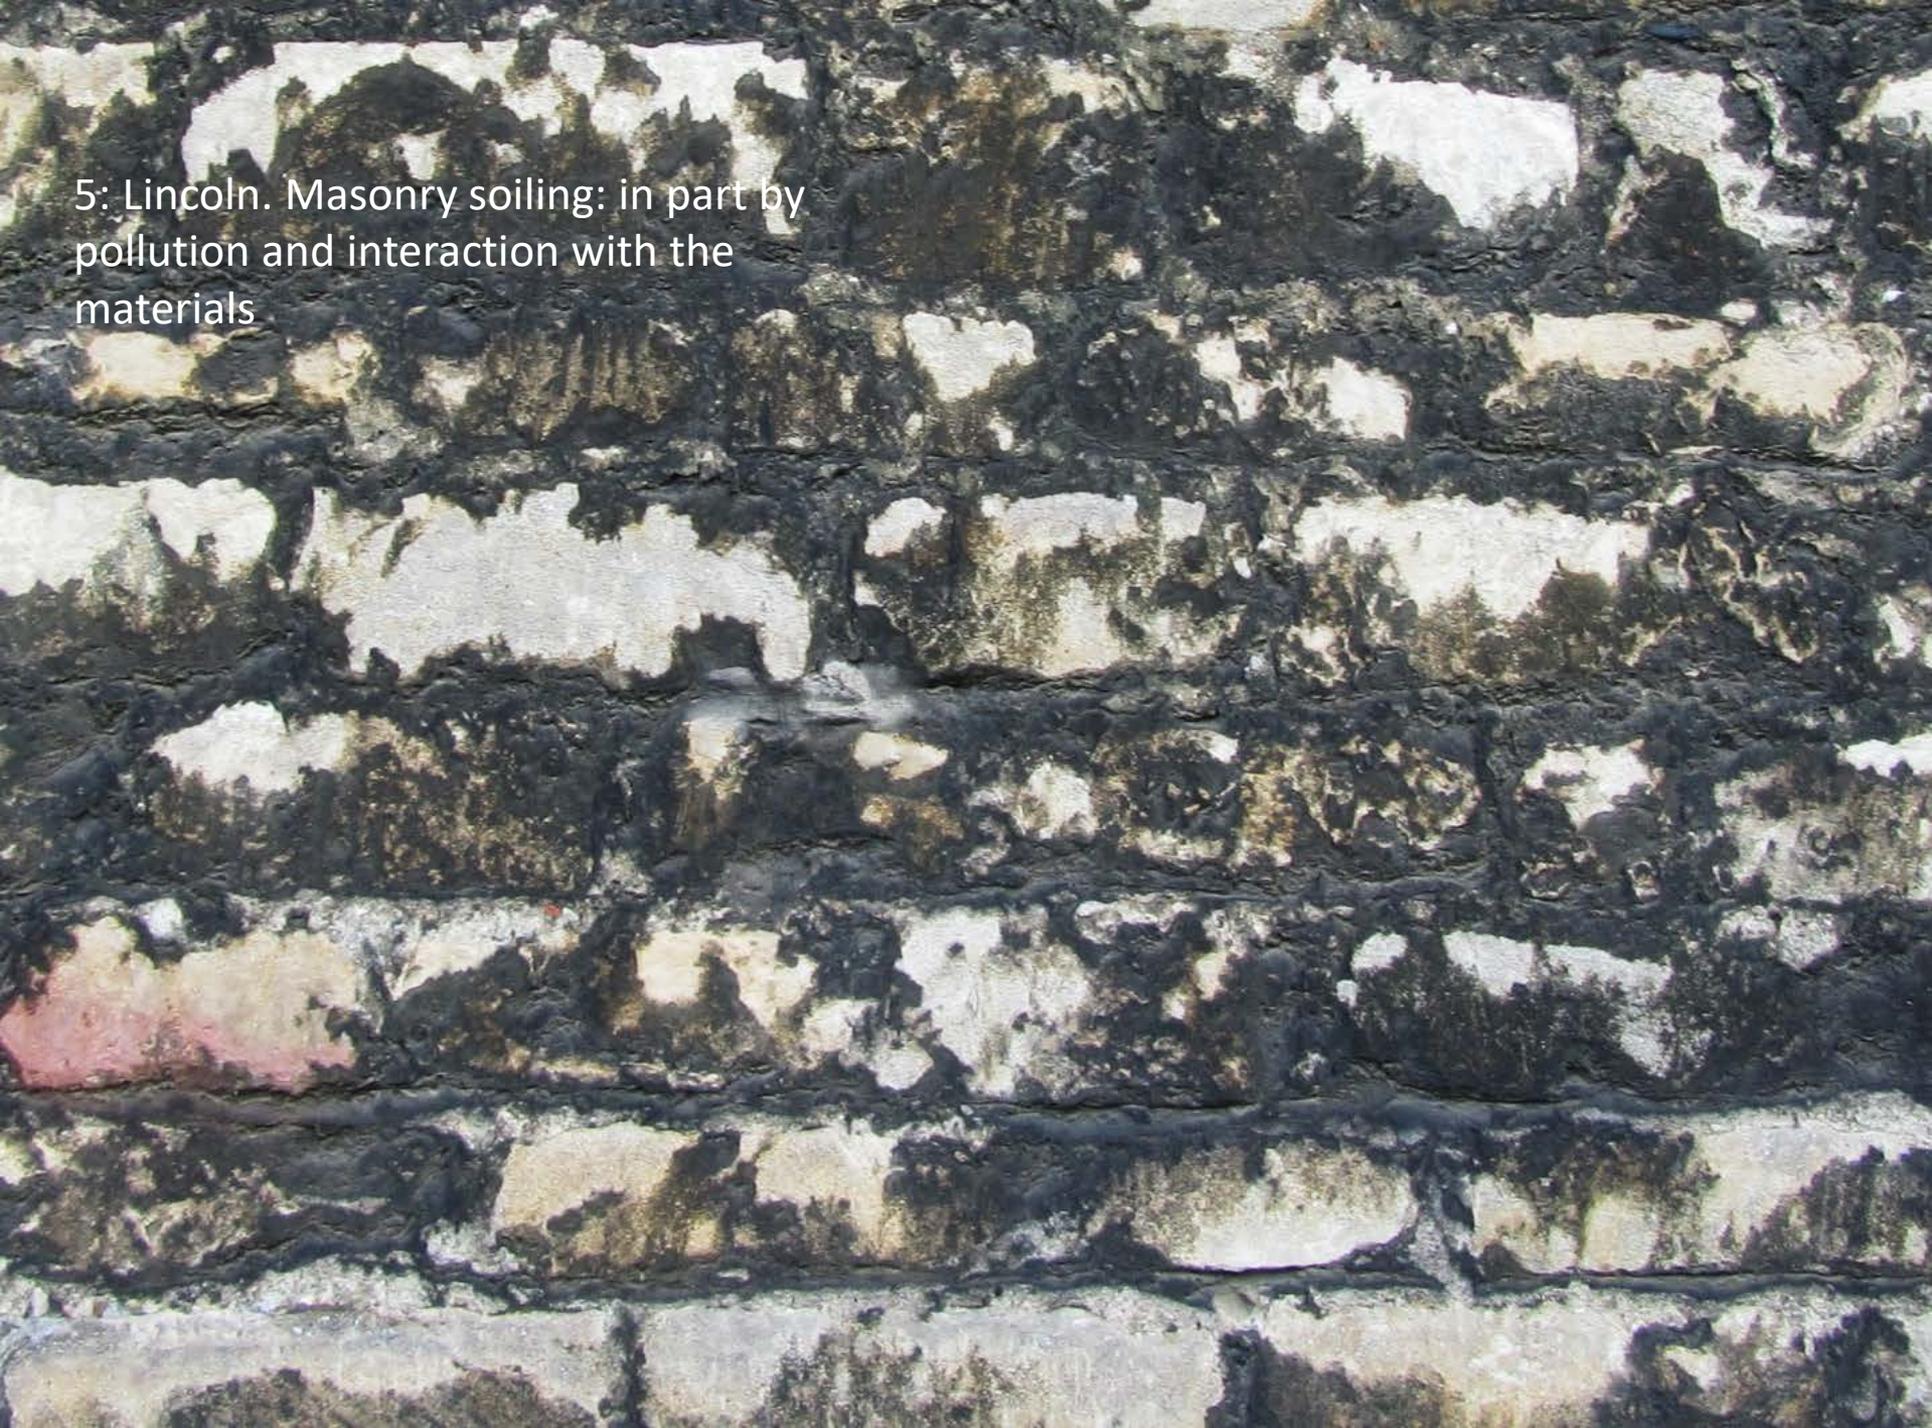
5: Lincoln. Masonry soiling: in part by pollution and interaction with the materials

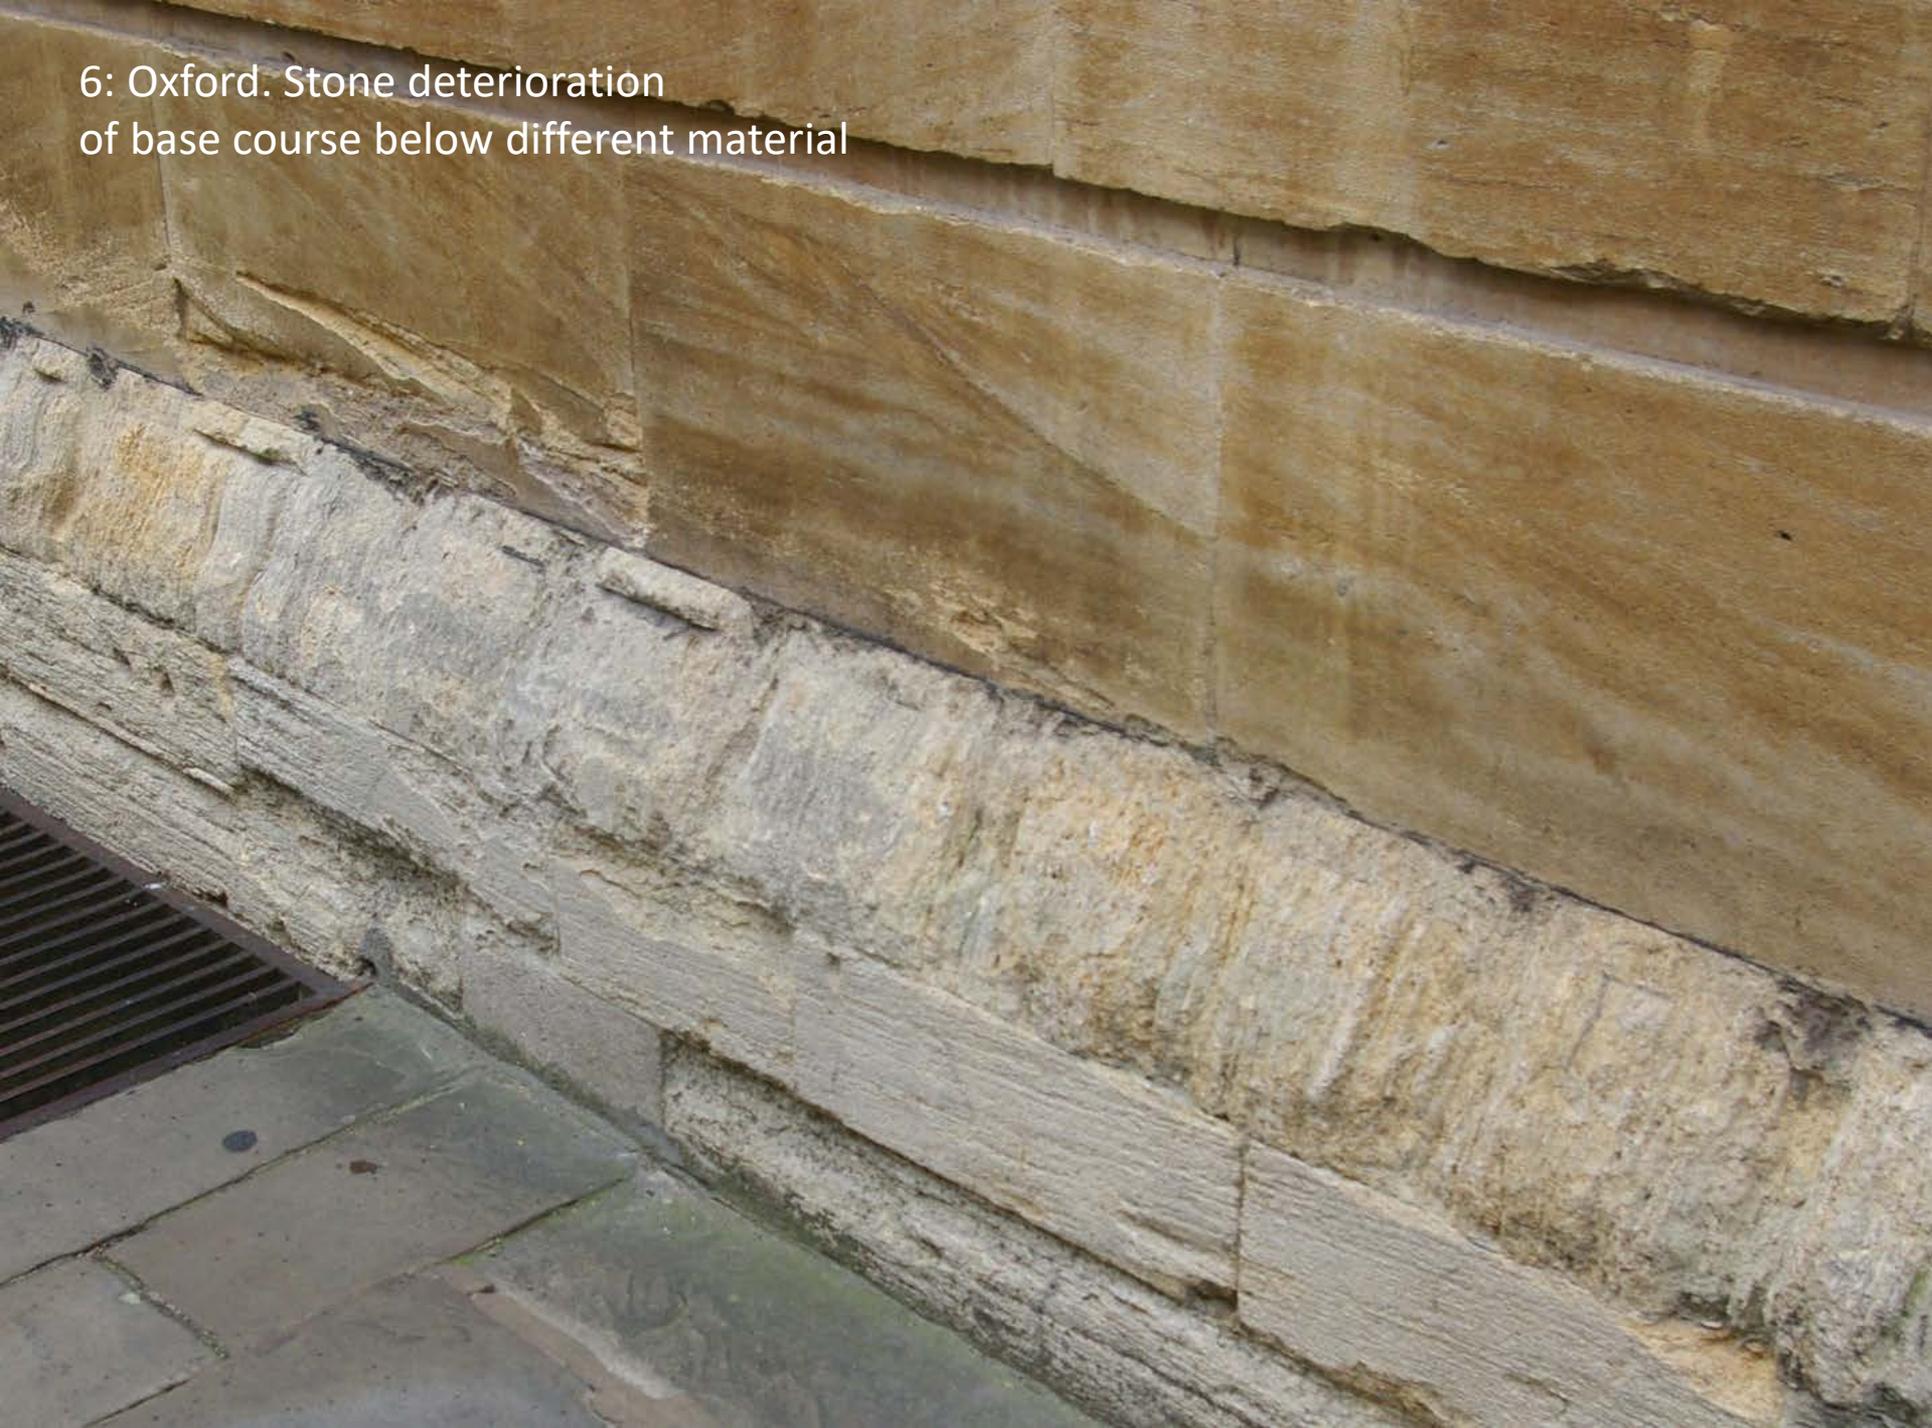
6: Oxford. Stone deterioration
of base course below different material

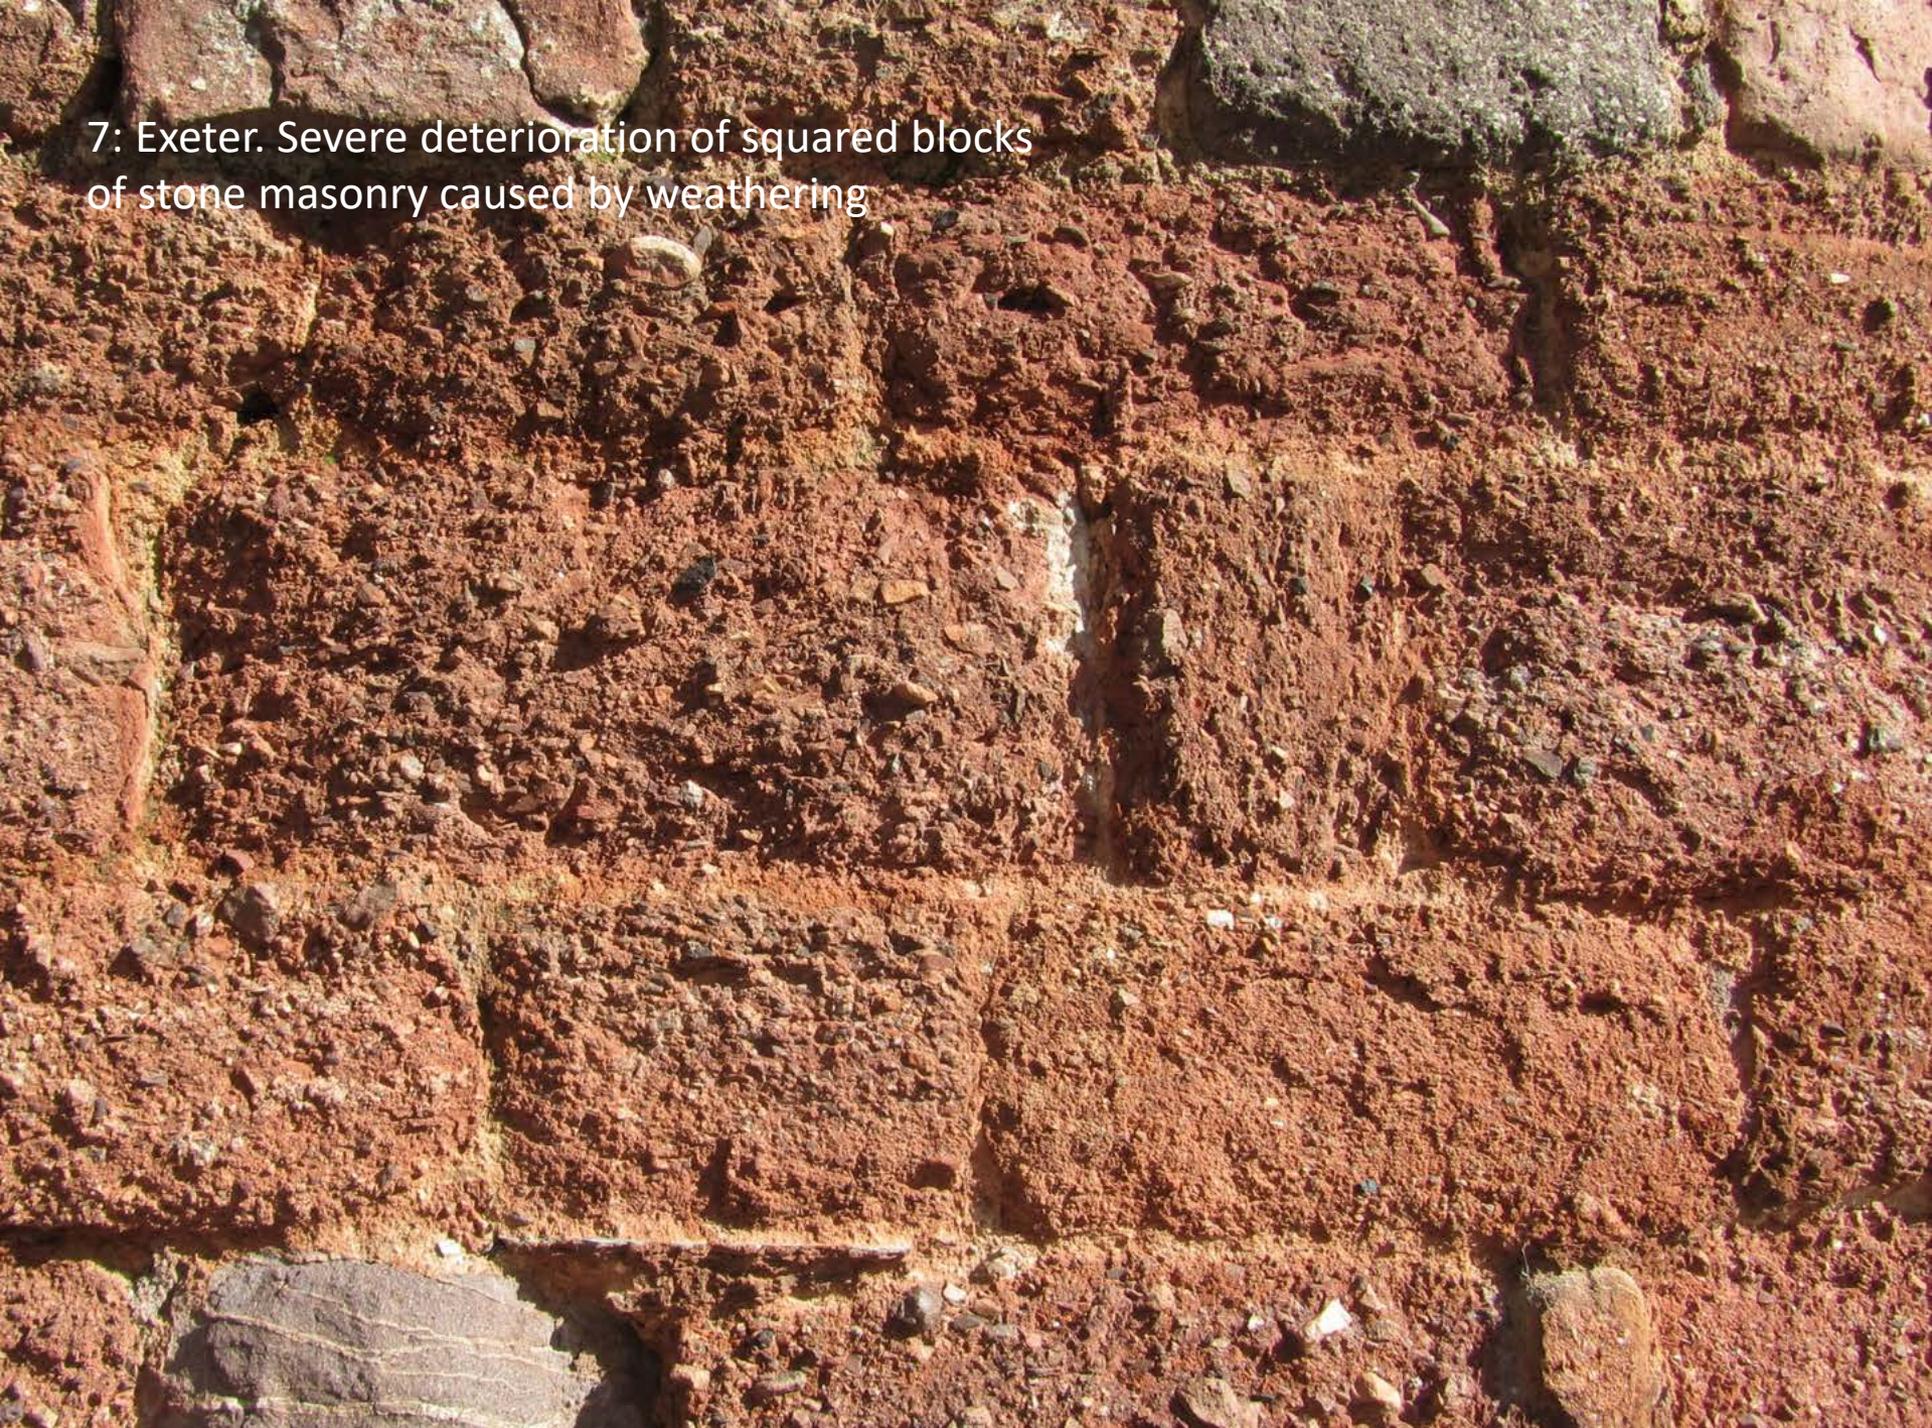
7: Exeter. Severe deterioration of squared blocks of stone masonry caused by weathering

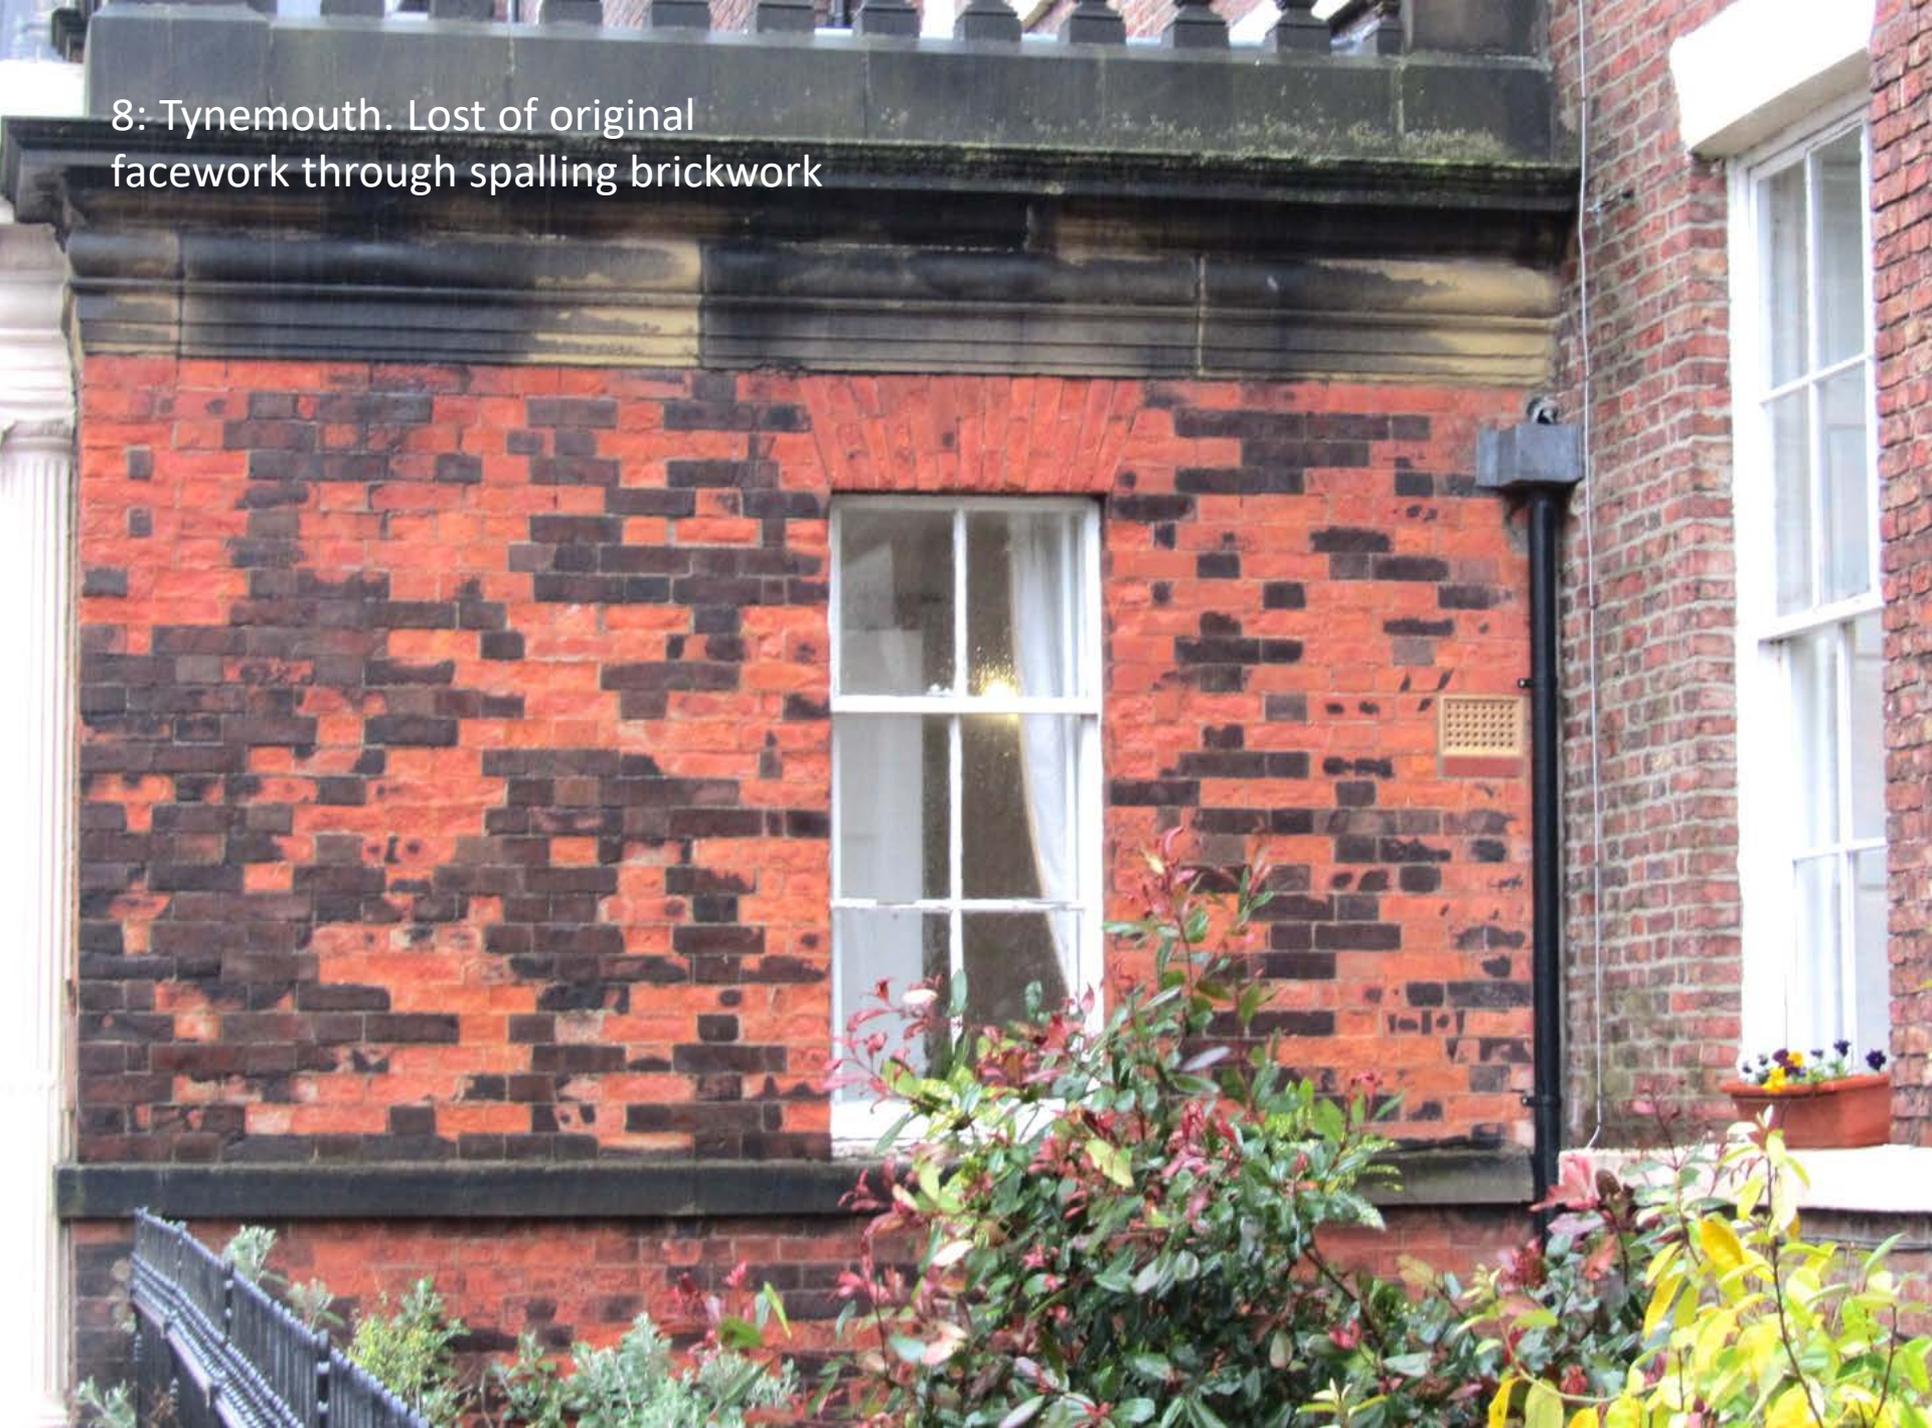
8: Tynemouth. Lost of original facework through spalling brickwork

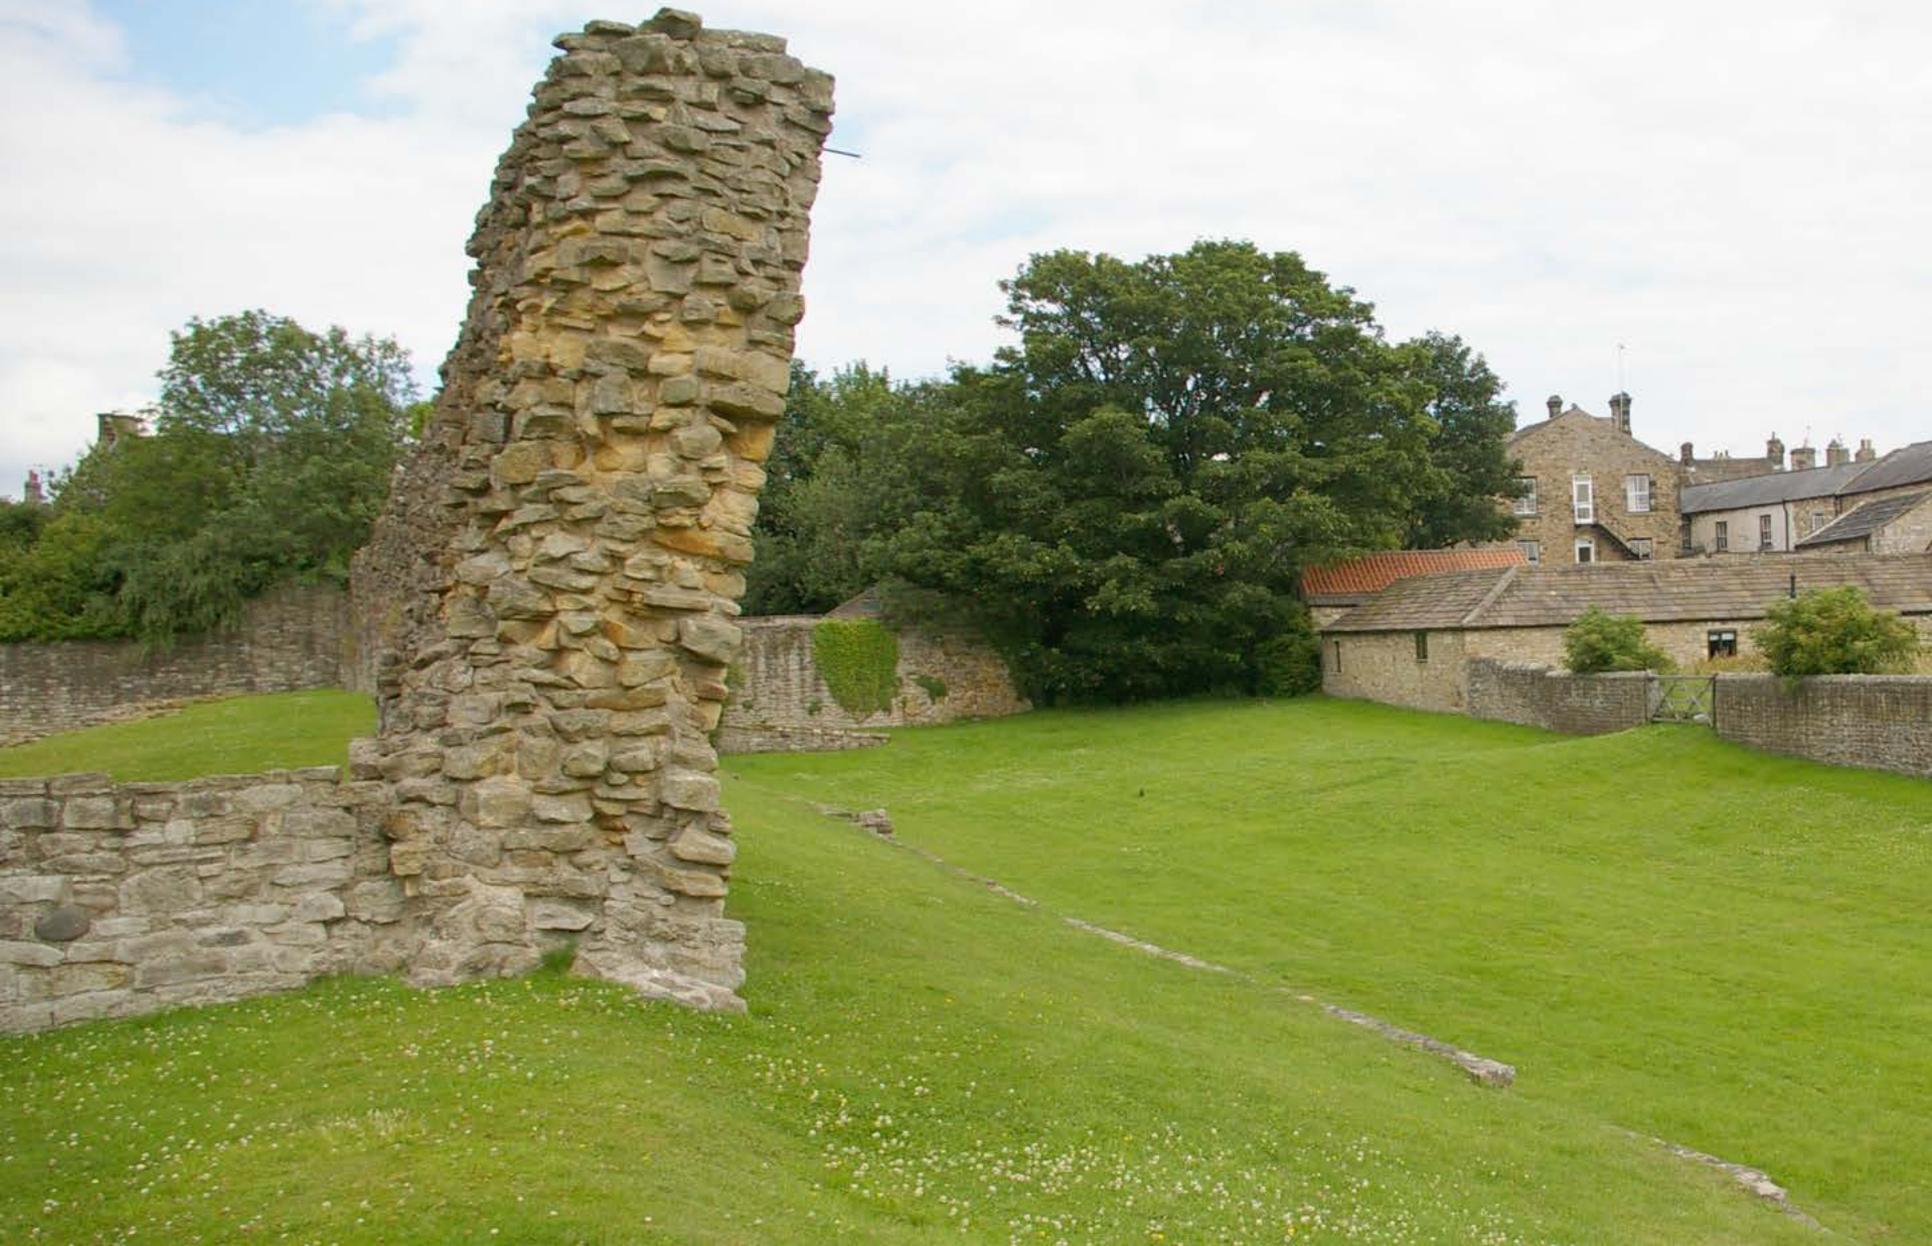
9: Barnard Castle. Structural movement as a result of ground movement

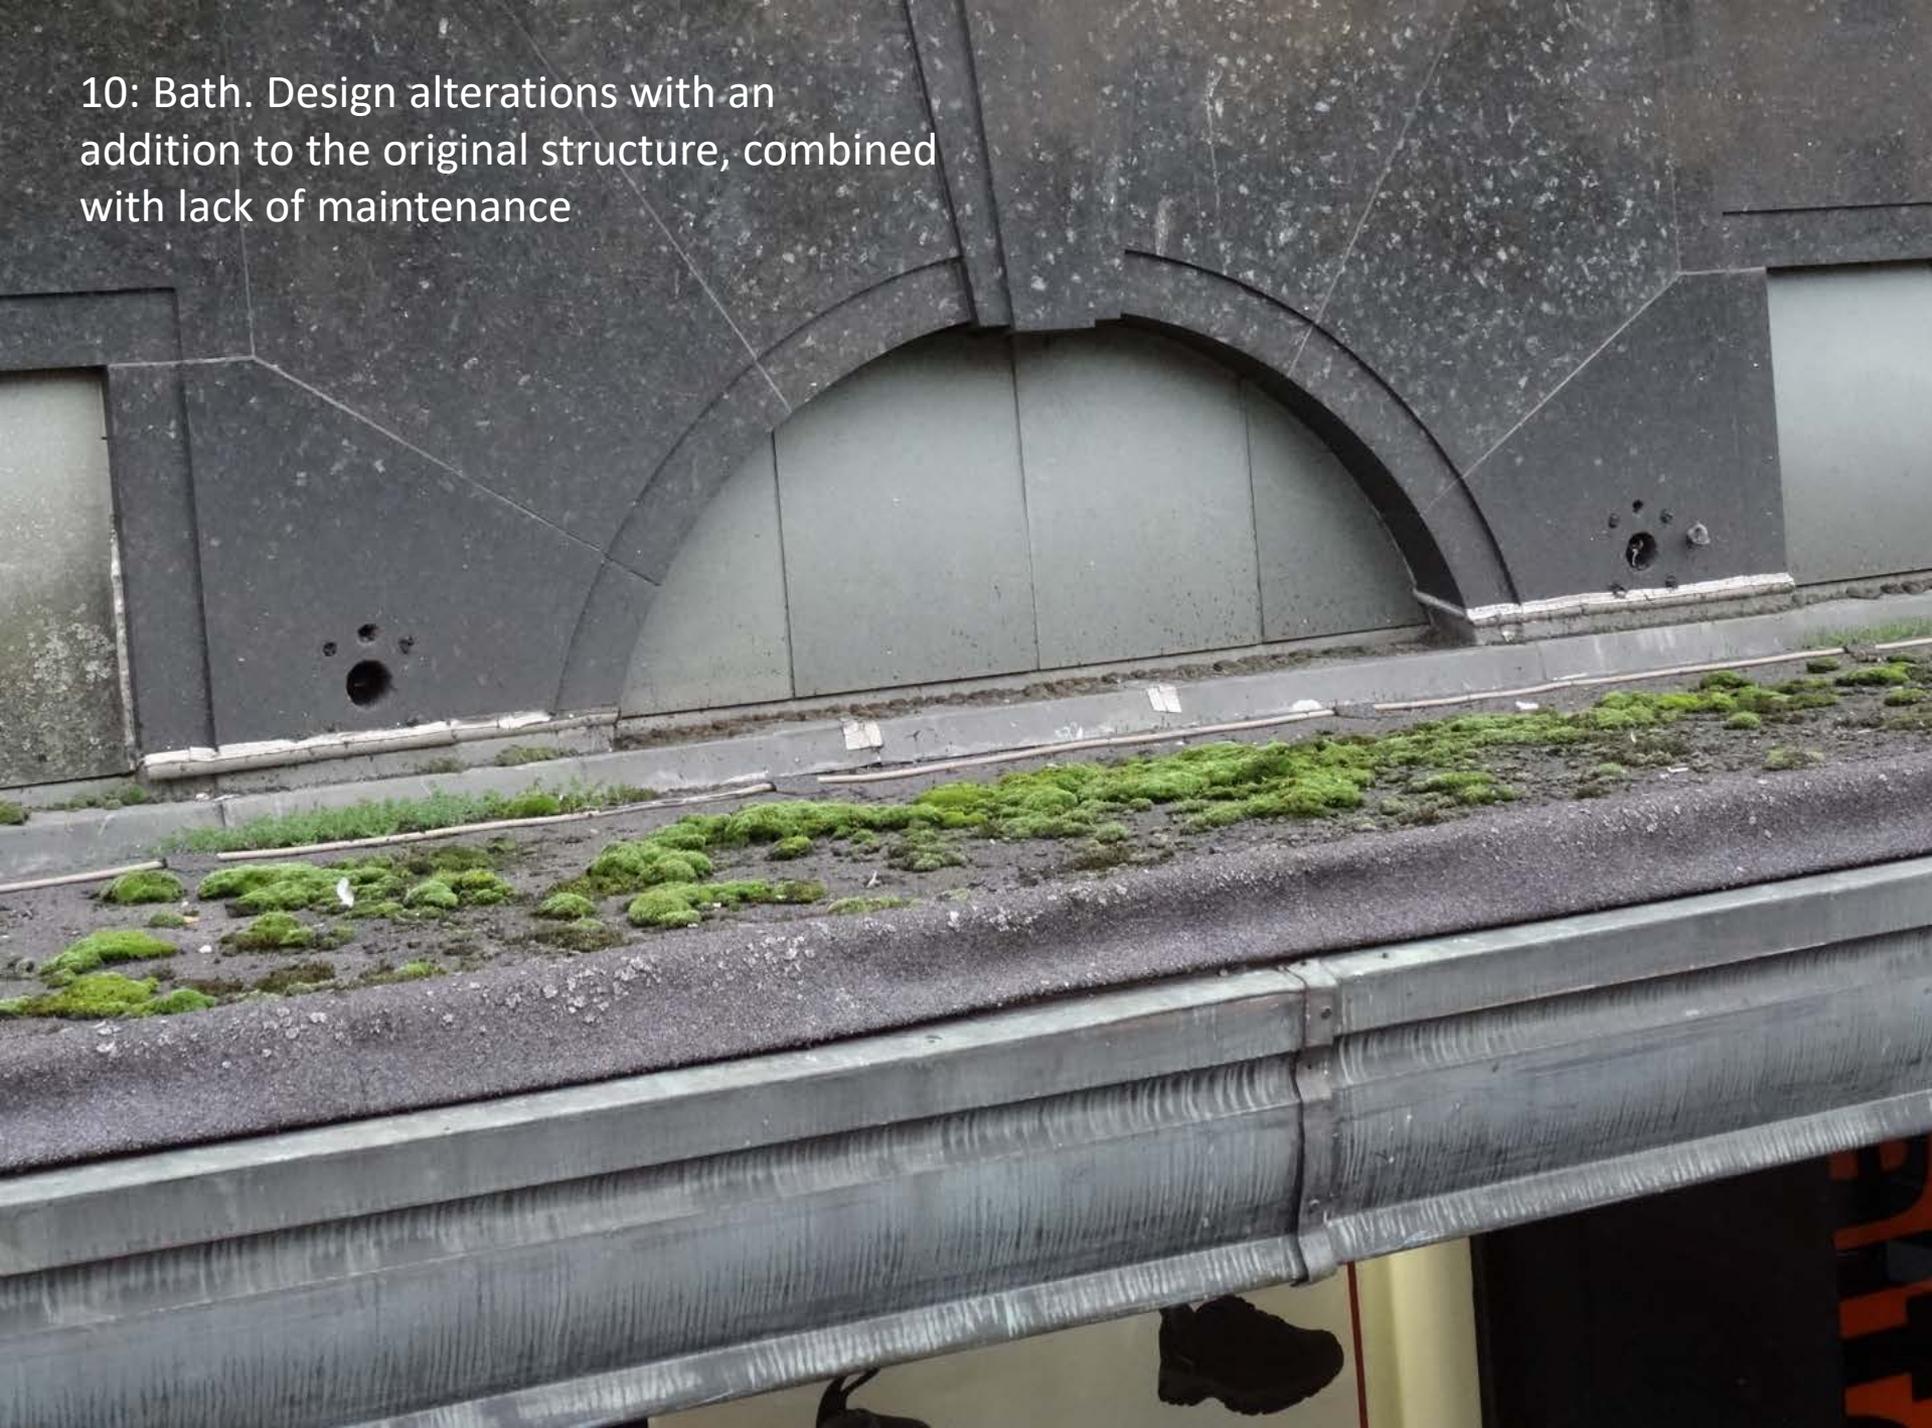
10: Bath. Design alterations with an addition to the original structure, combined with lack of maintenance
