Insight 1 Unit 3: Image Set

How does a building work?

The Insight Unit relates to the www.understandingconservation.org Unit3: Investigation, materials and technology to offer pointers as to how such investigations might be structured and what needs to be covered.

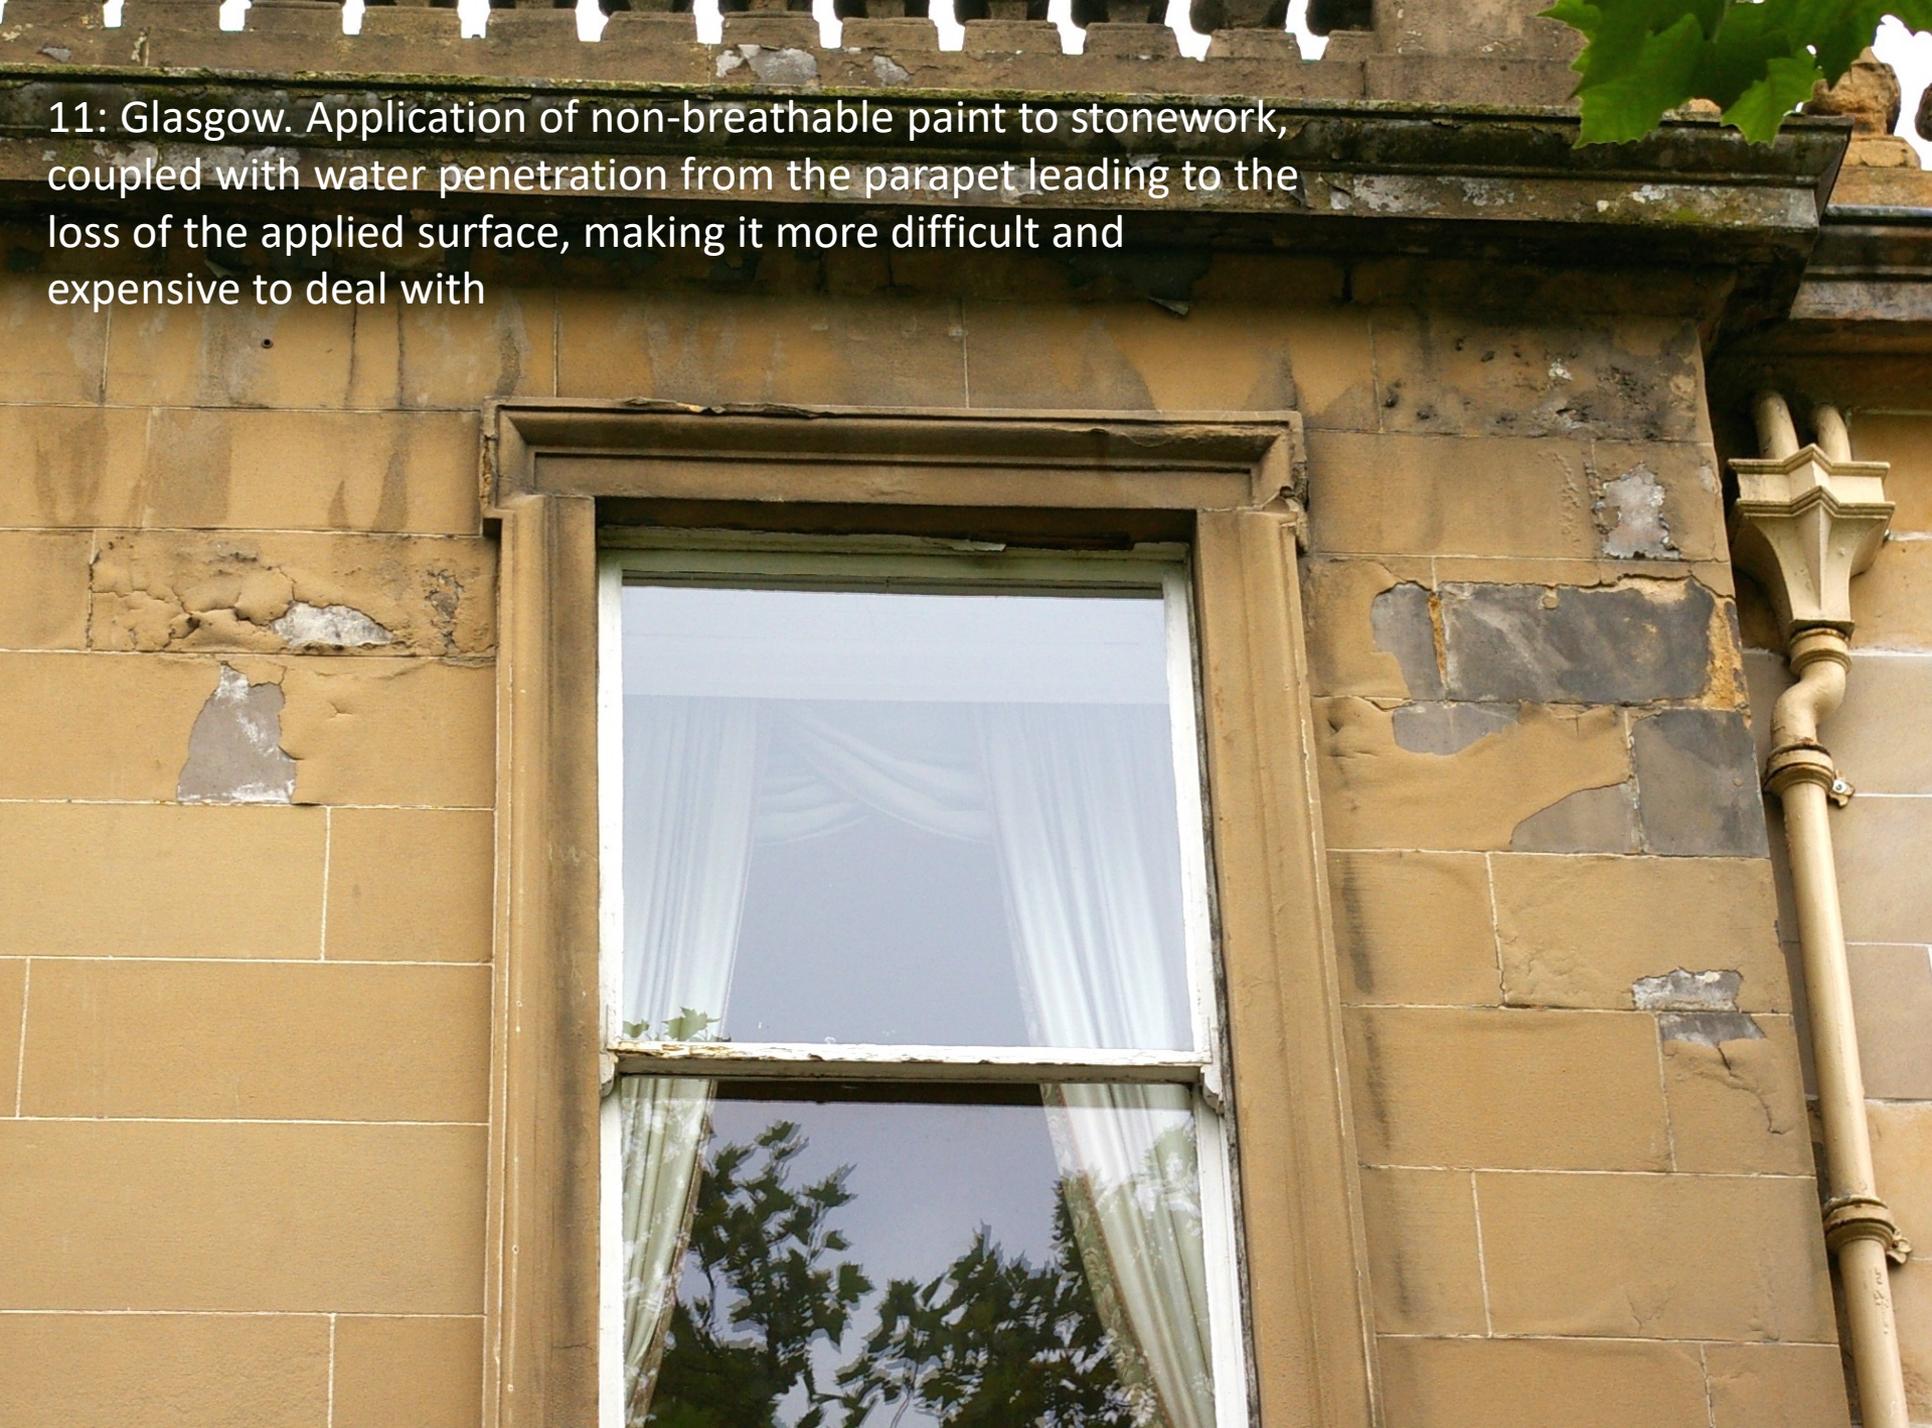
11: Glasgow. Application of non-breathable paint to stonework, coupled with water penetration from the parapet leading to the loss of the applied surface, making it more difficult and expensive to deal with

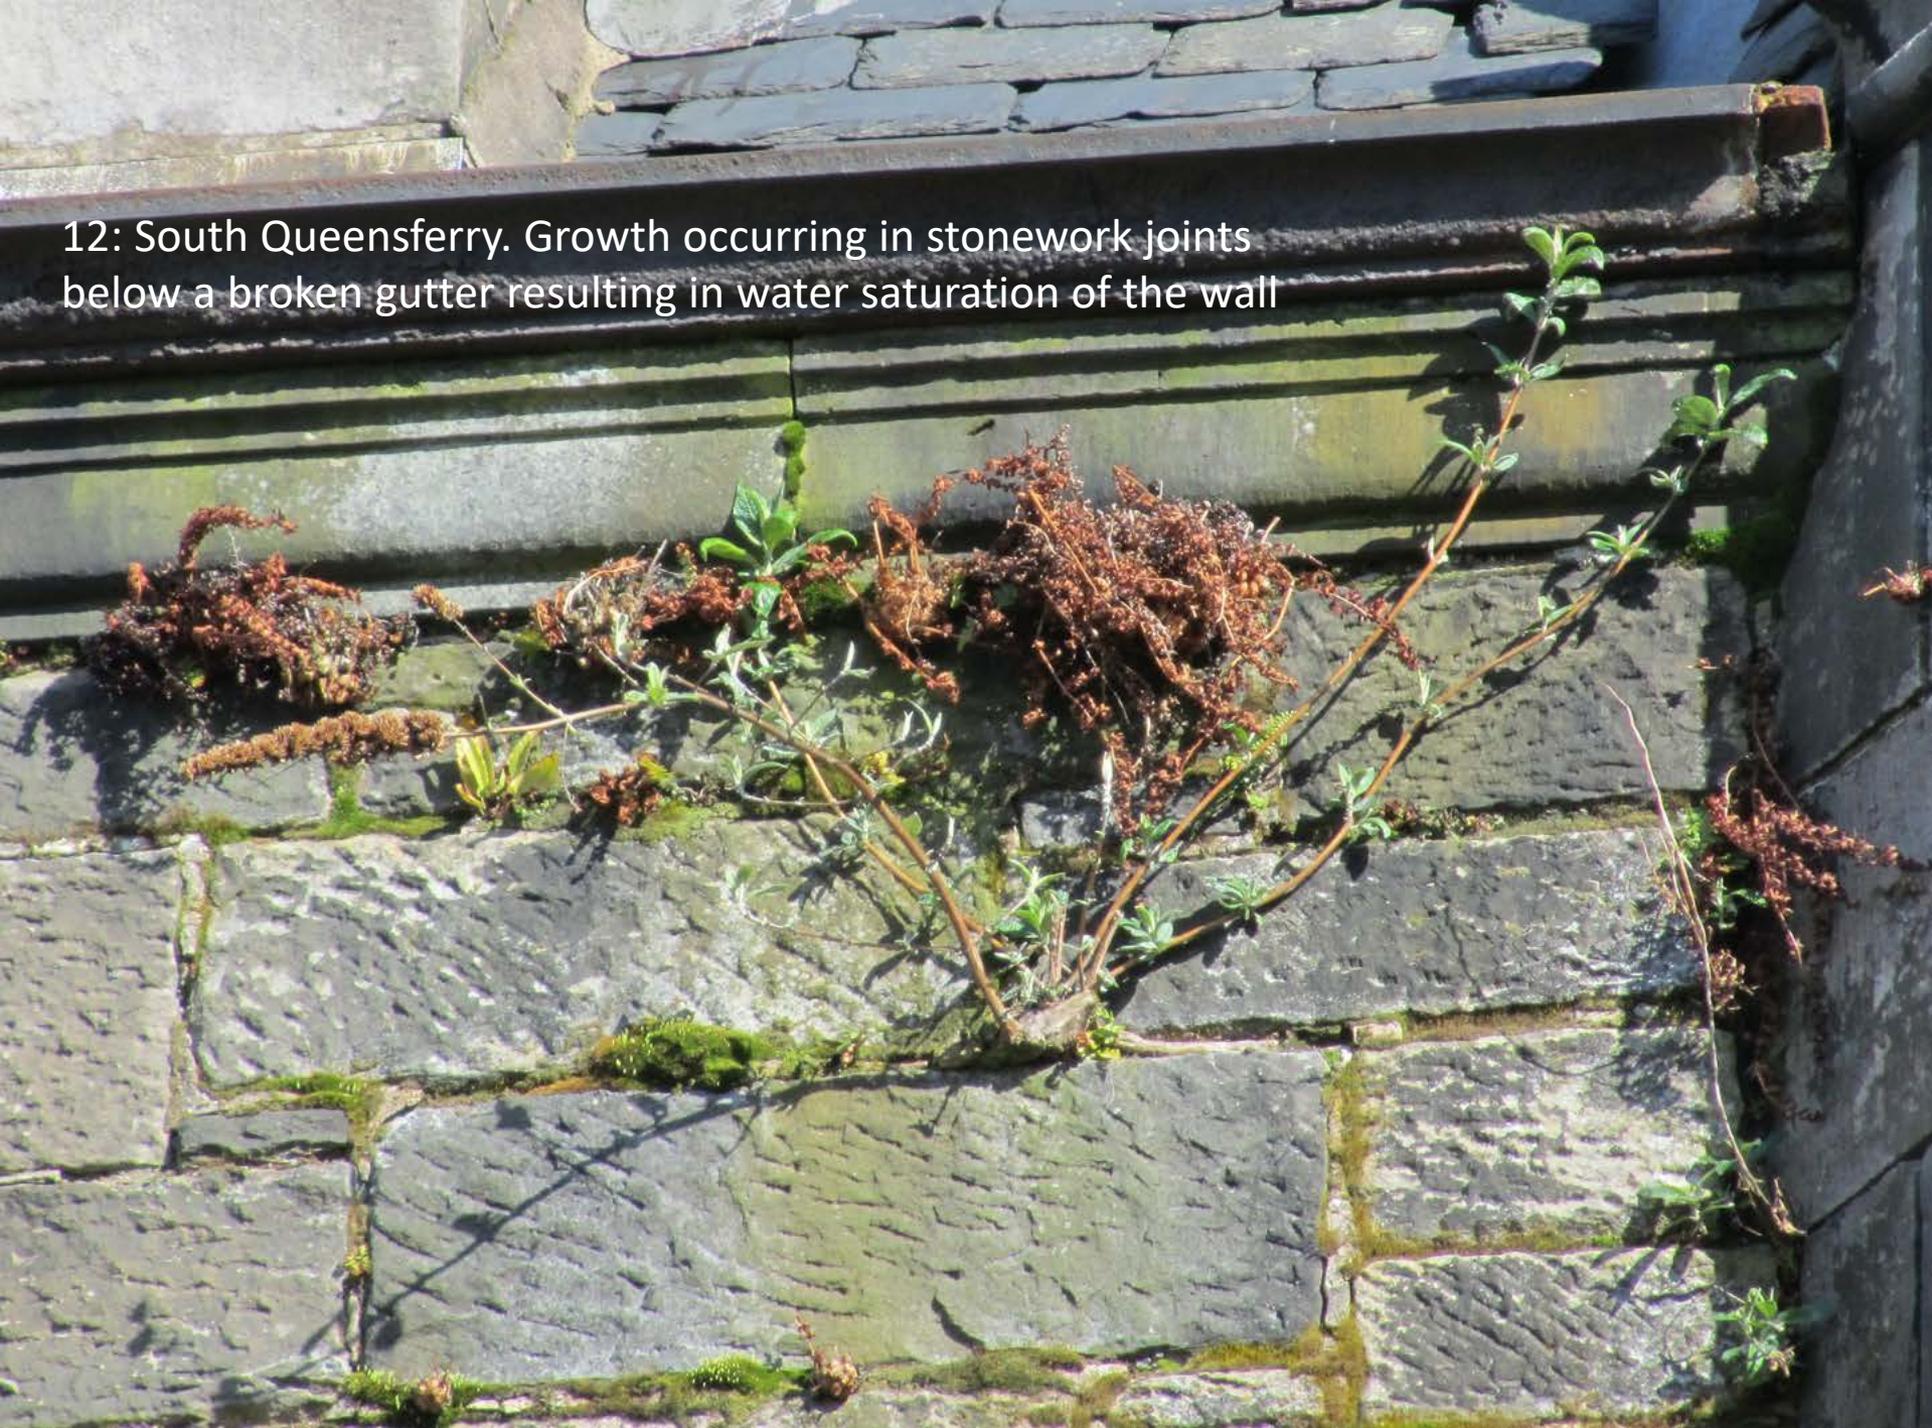
12: South Queensferry. Growth occurring in stonework joints below a broken gutter resulting in water saturation of the wall

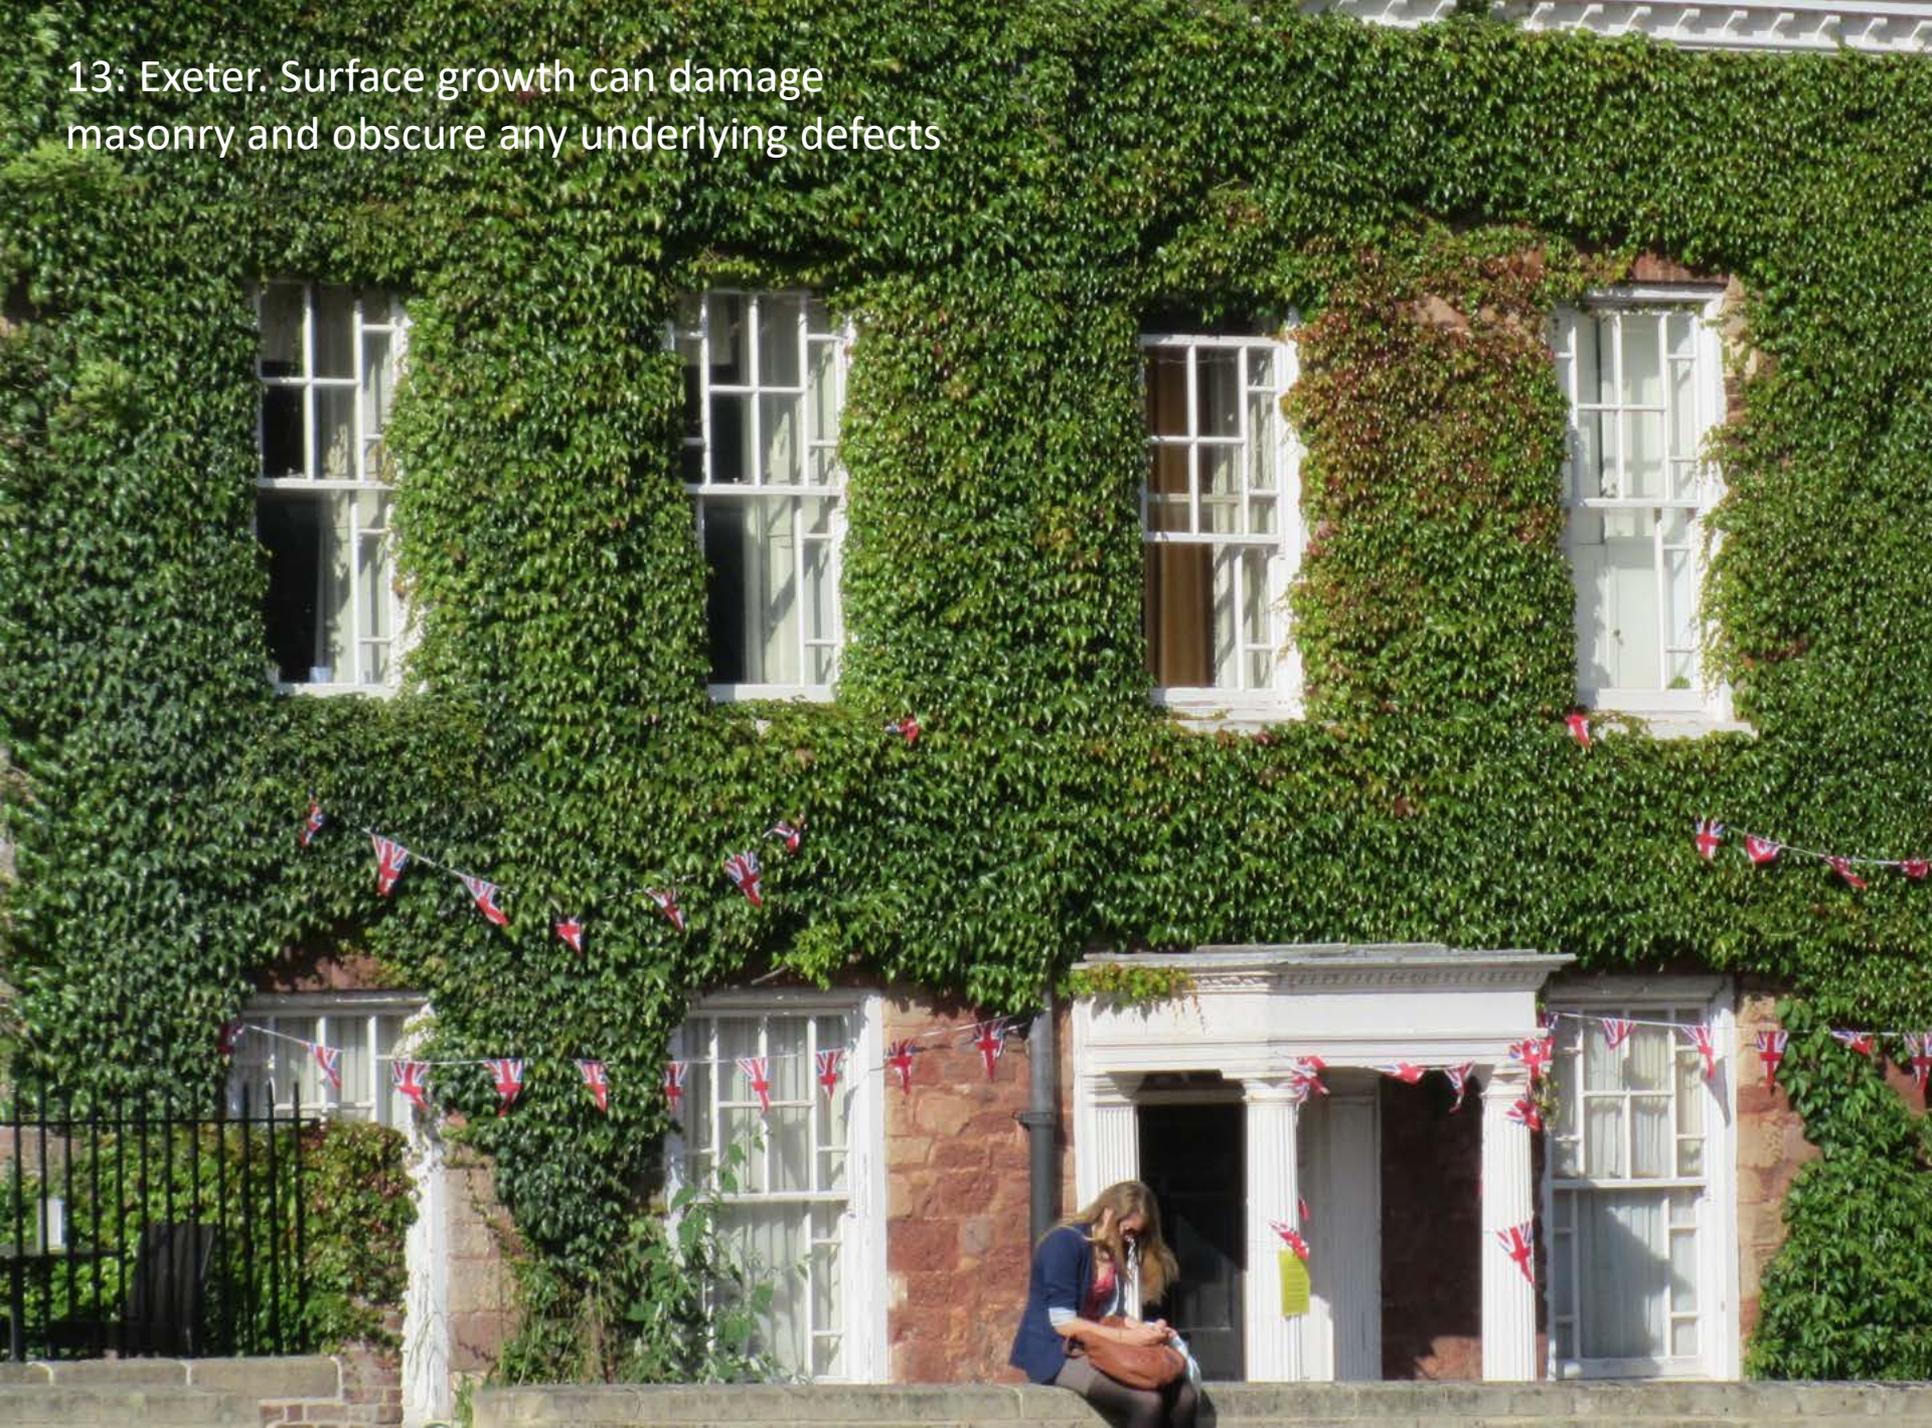
13: Exeter. Surface growth can damage masonry and obscure any underlying defects

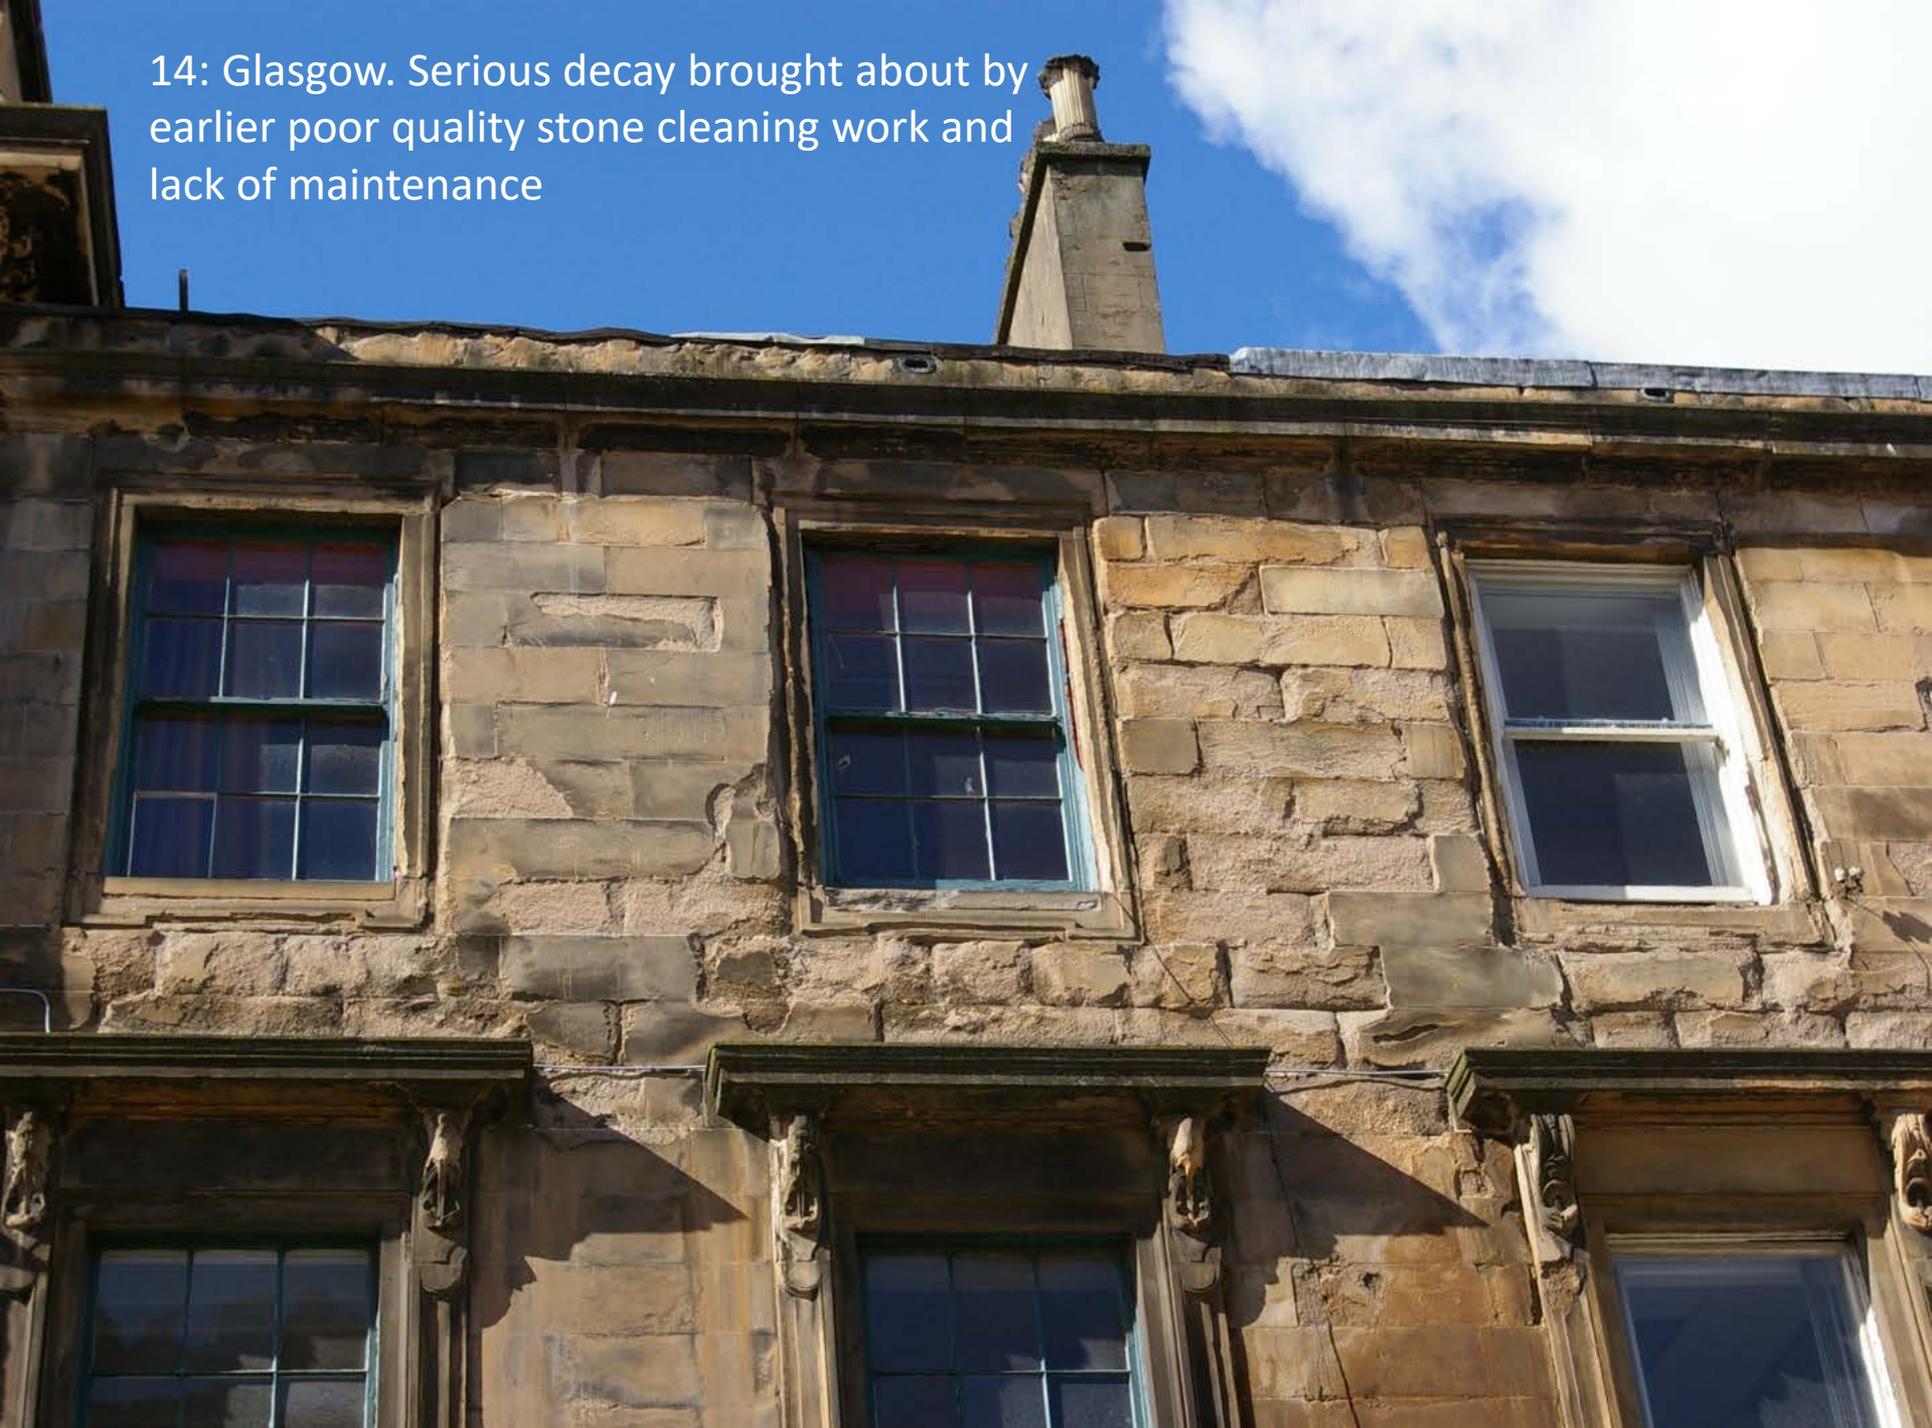
14: Glasgow. Serious decay brought about by earlier poor quality stone cleaning work and lack of maintenance

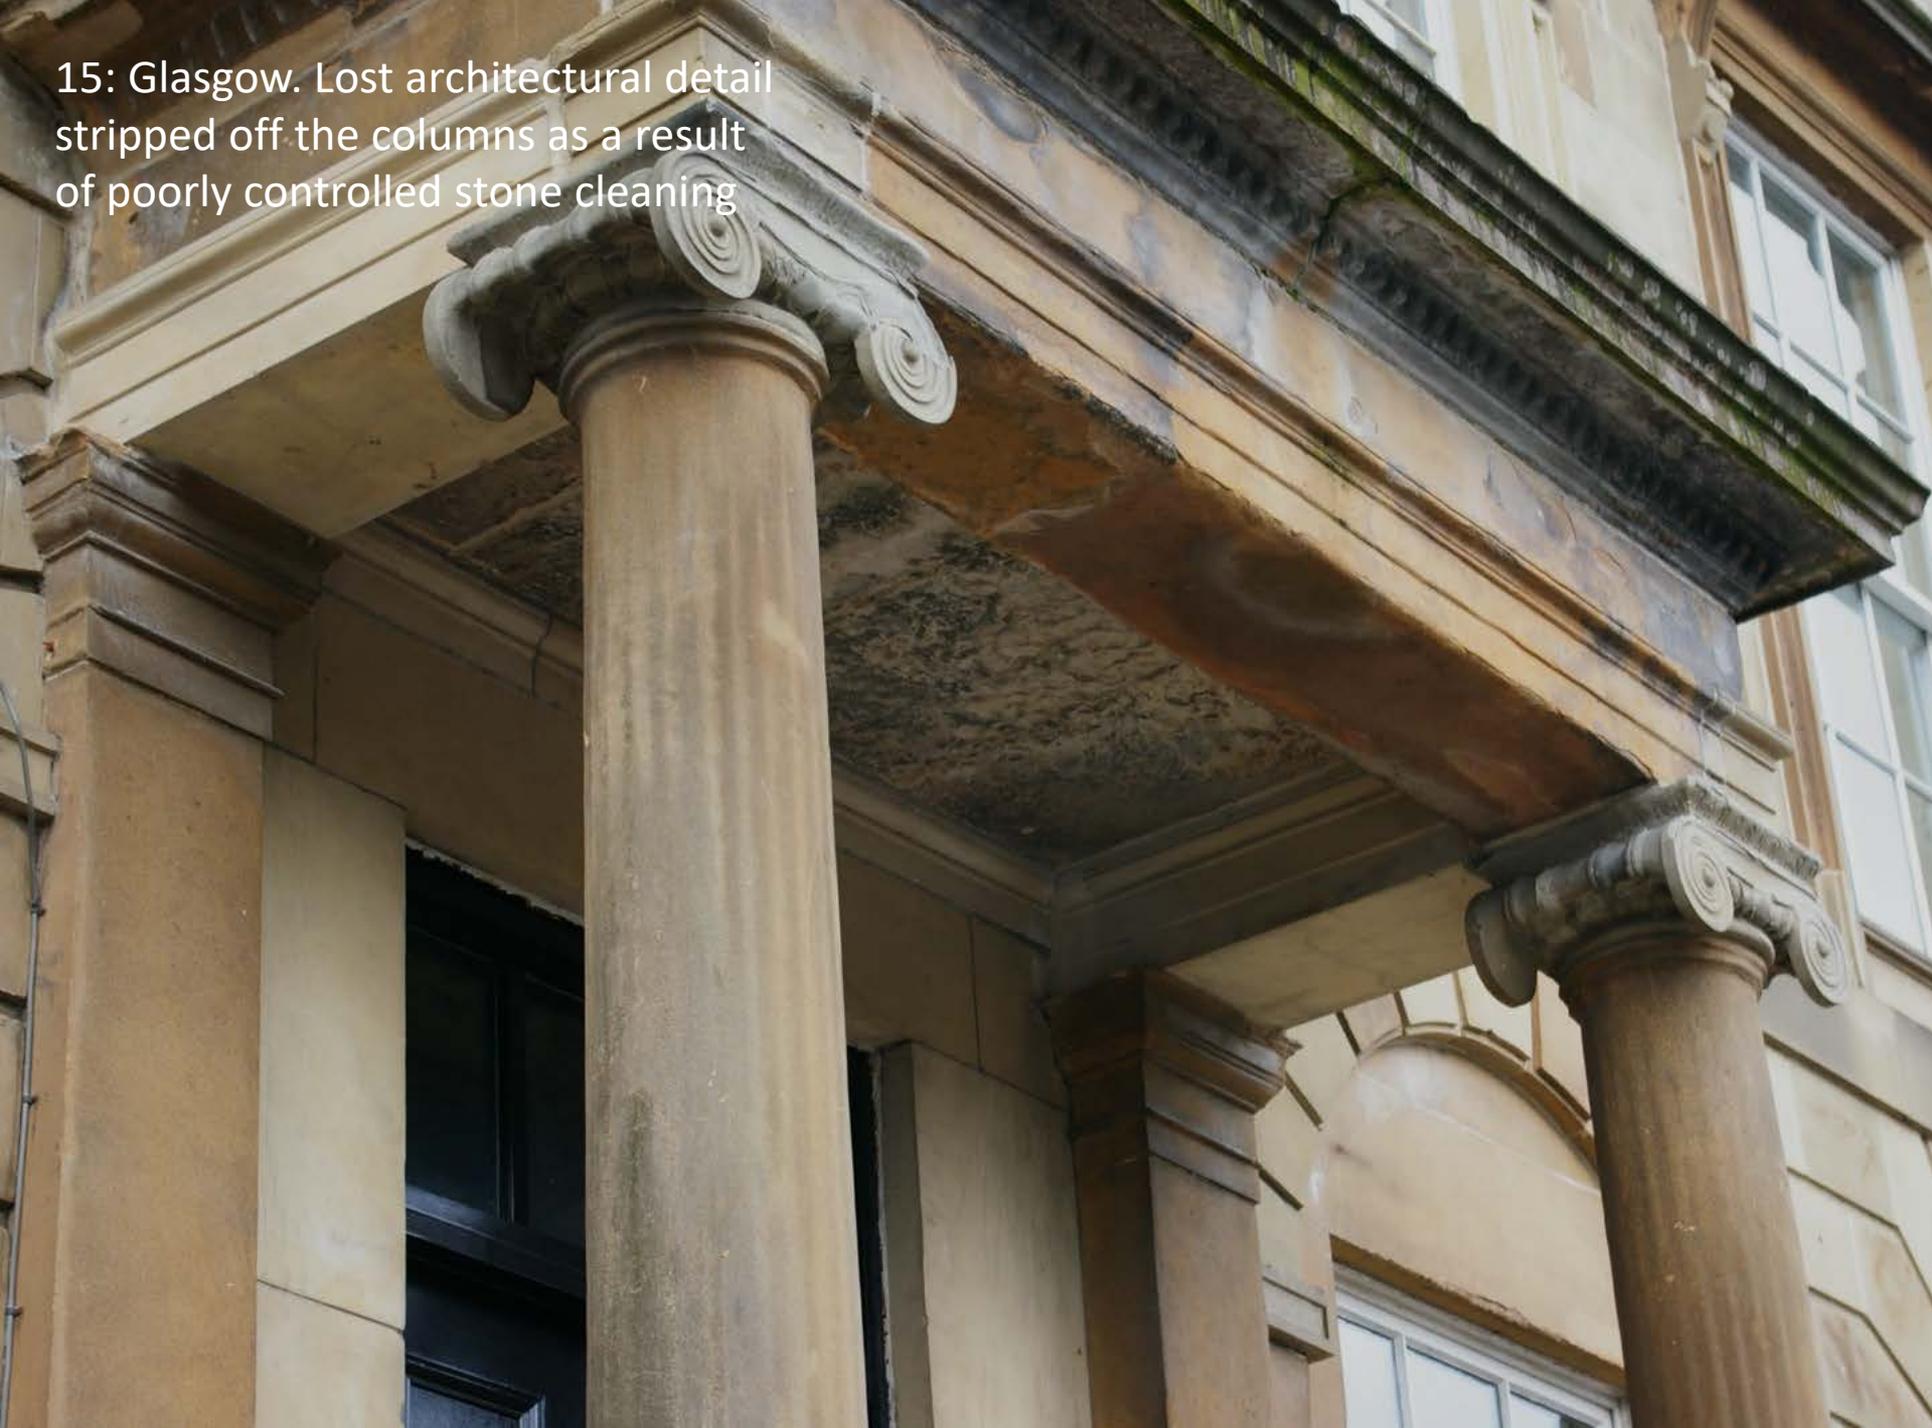
15: Glasgow. Lost architectural detail
stripped off the columns as a result
of poorly controlled stone cleaning

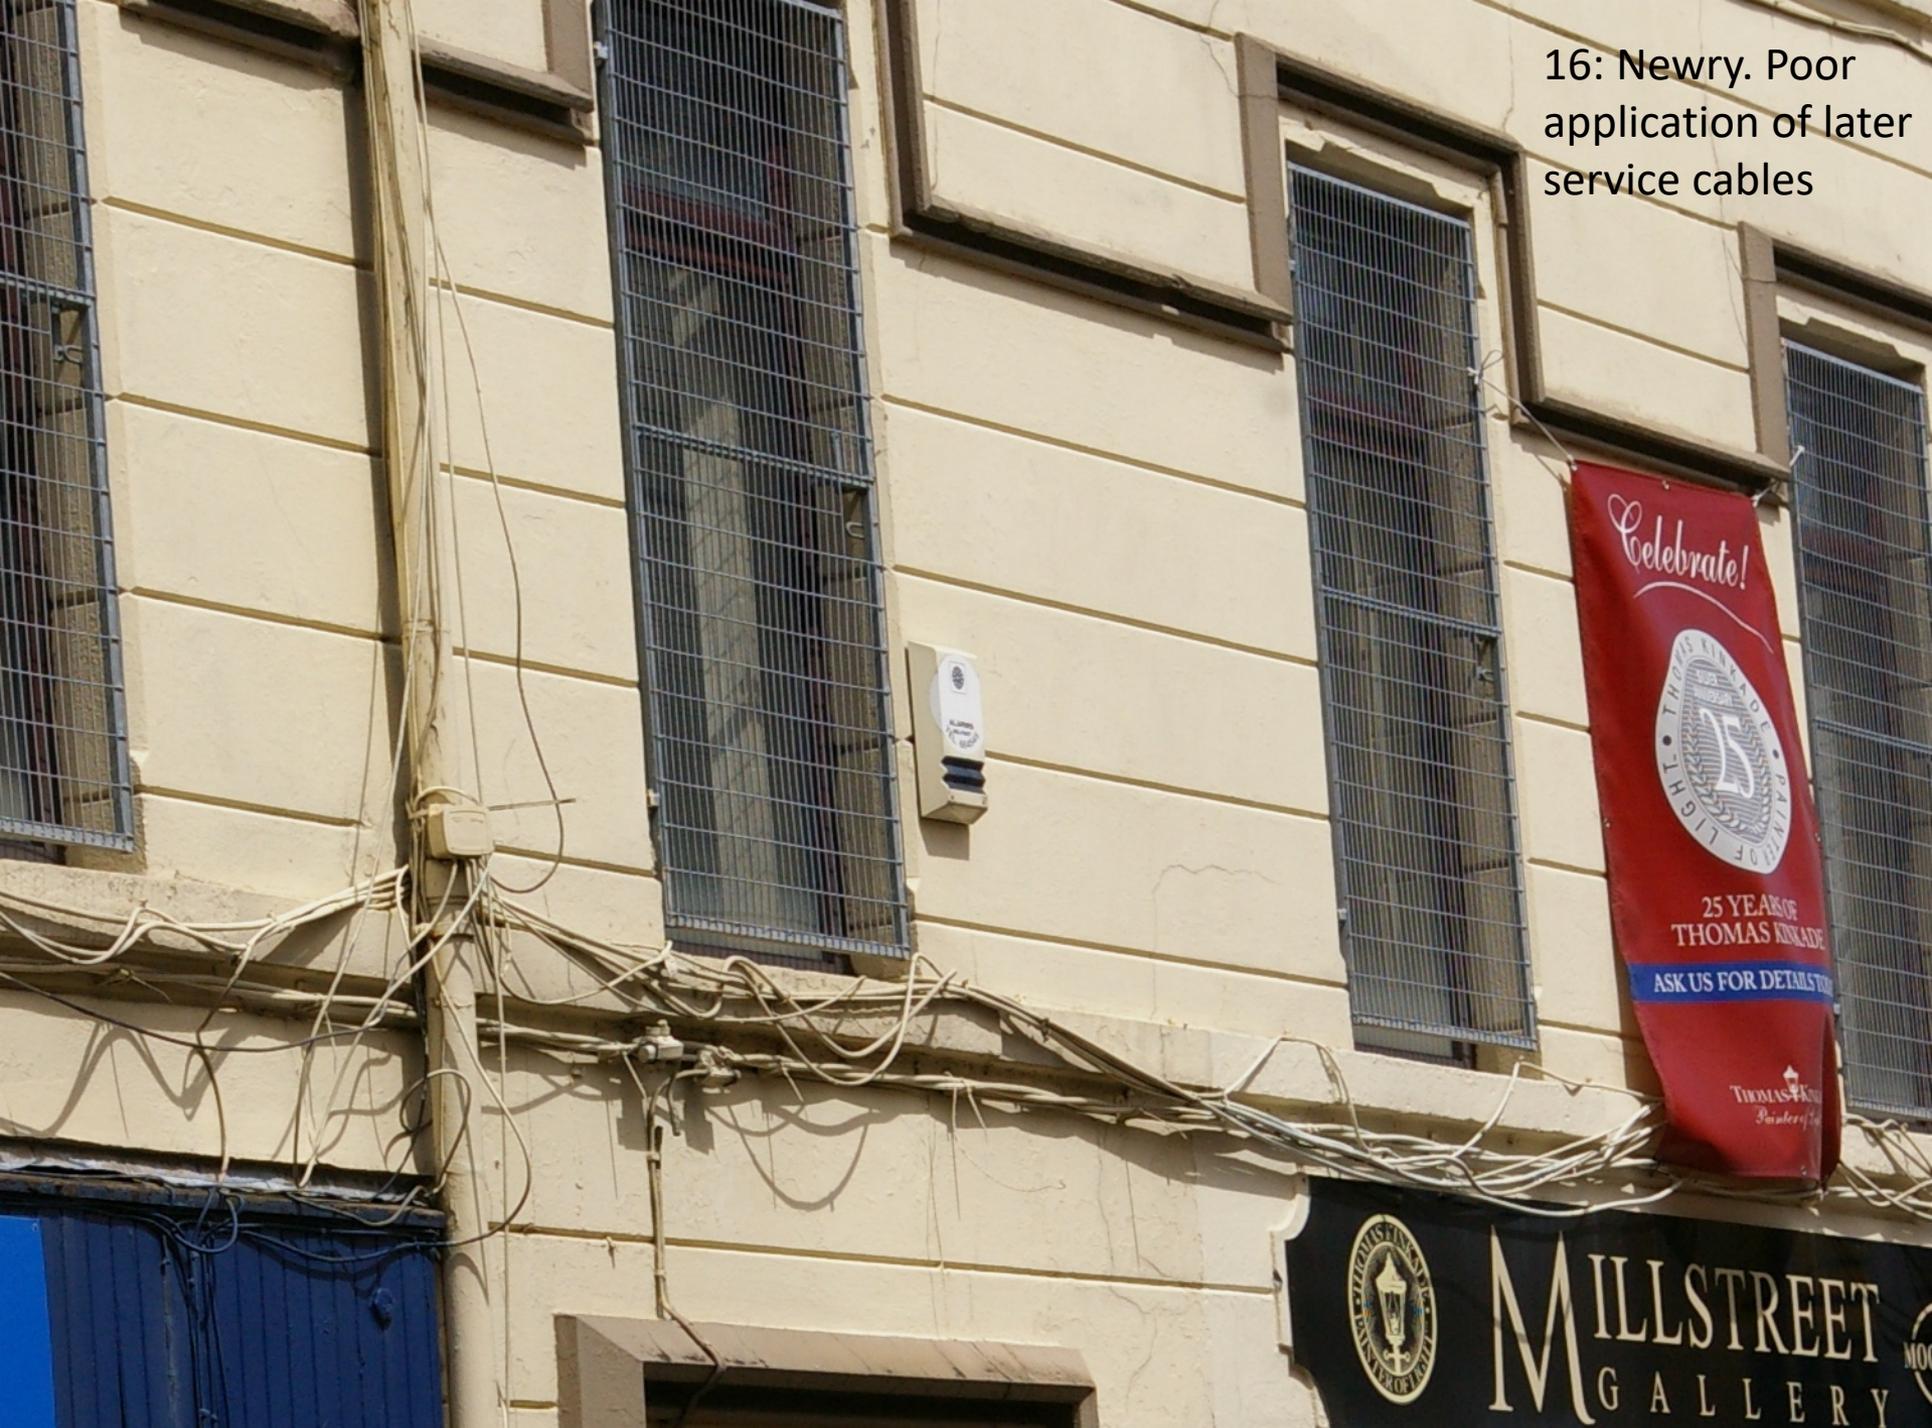
16: Newry. Poor application of later service cables

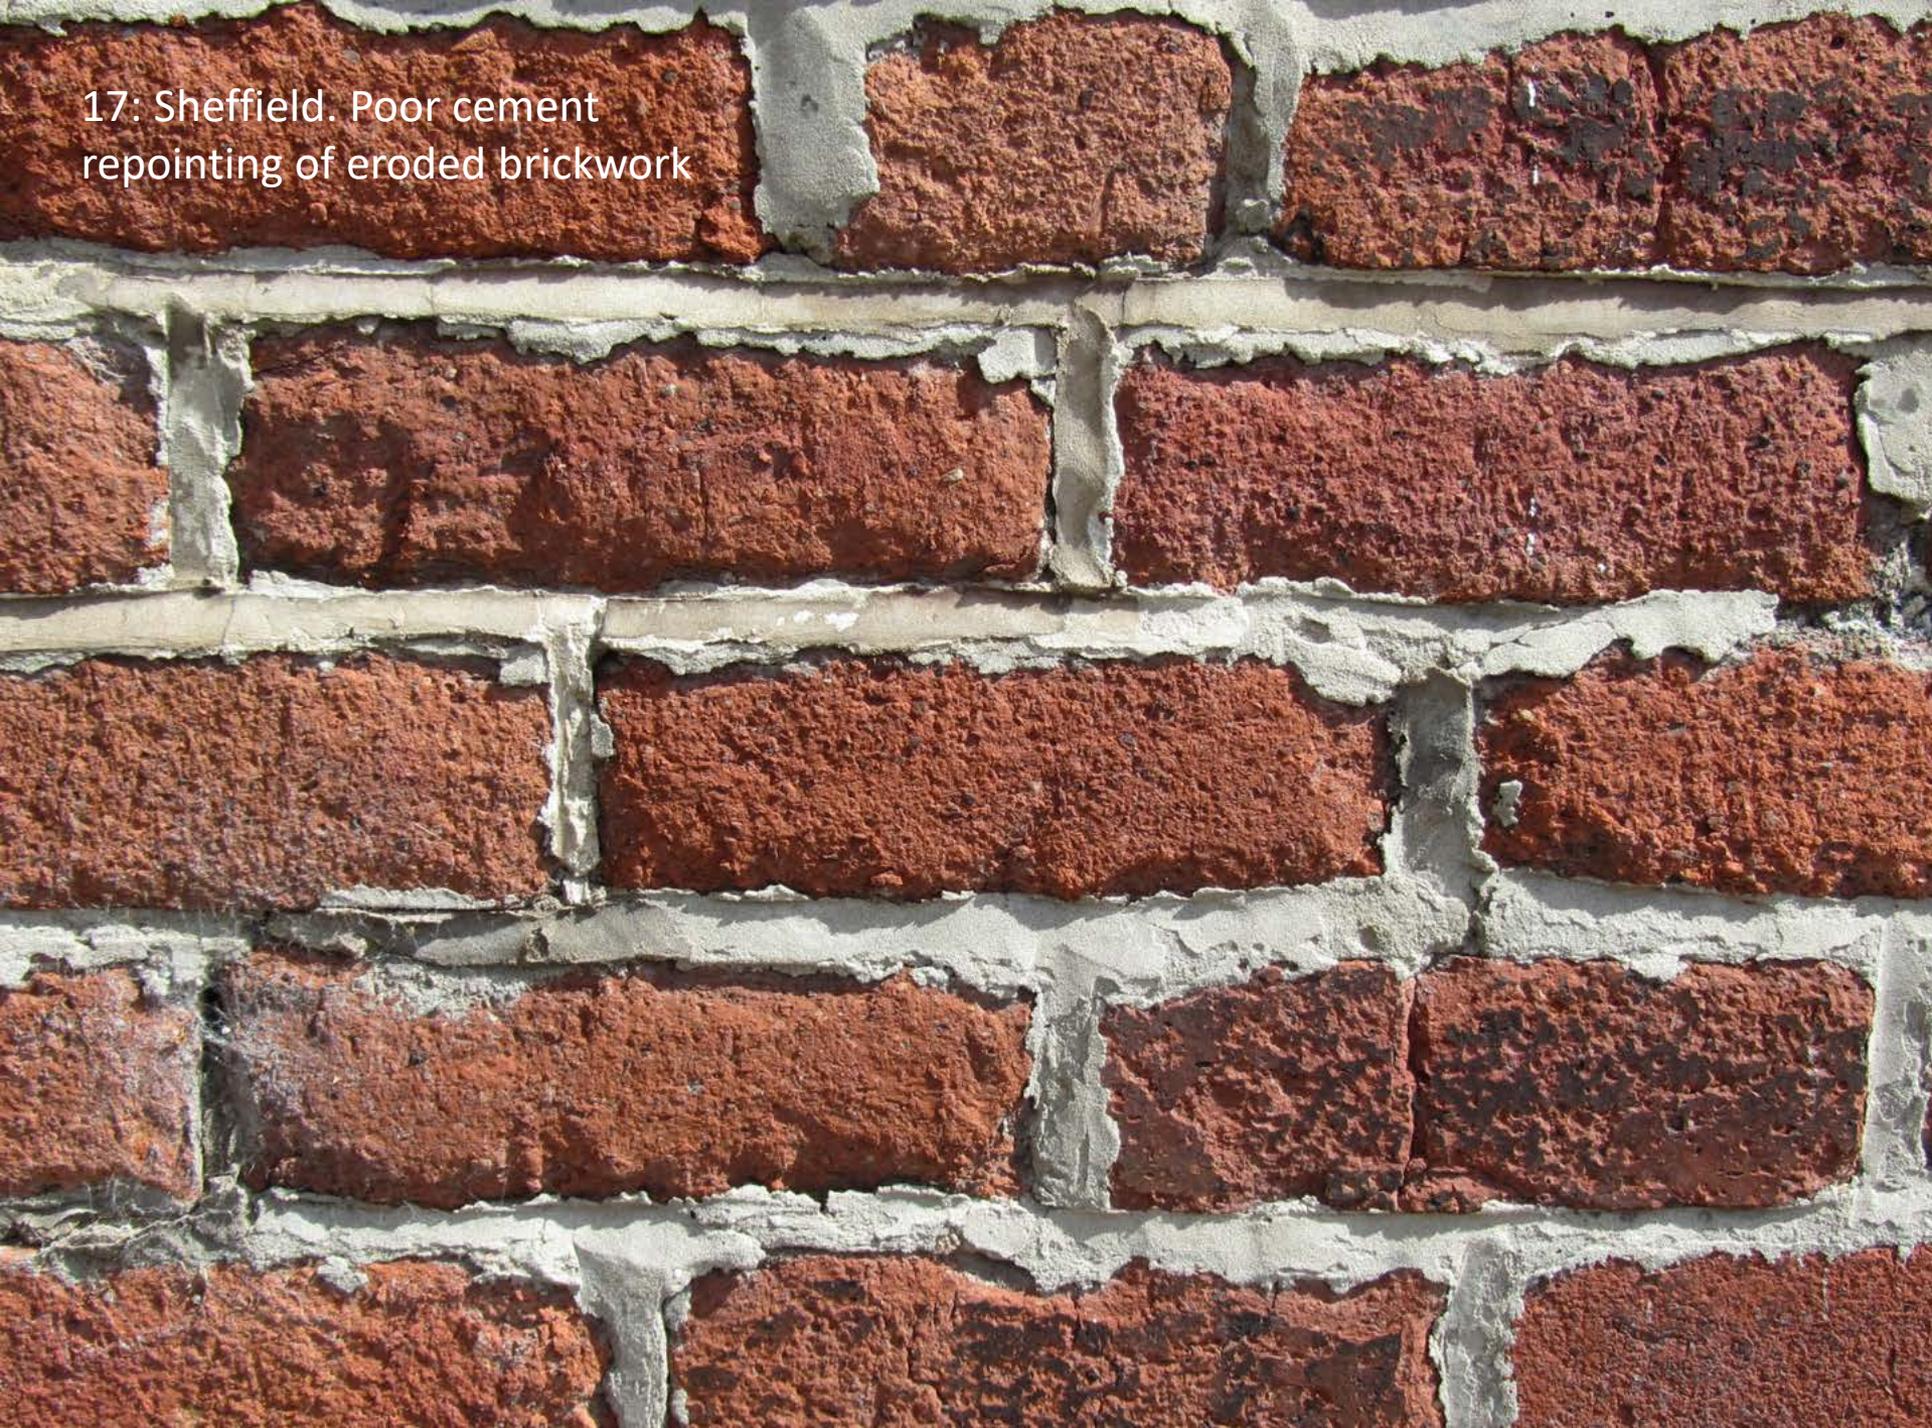
17: Sheffield. Poor cement
repointing of eroded brickwork

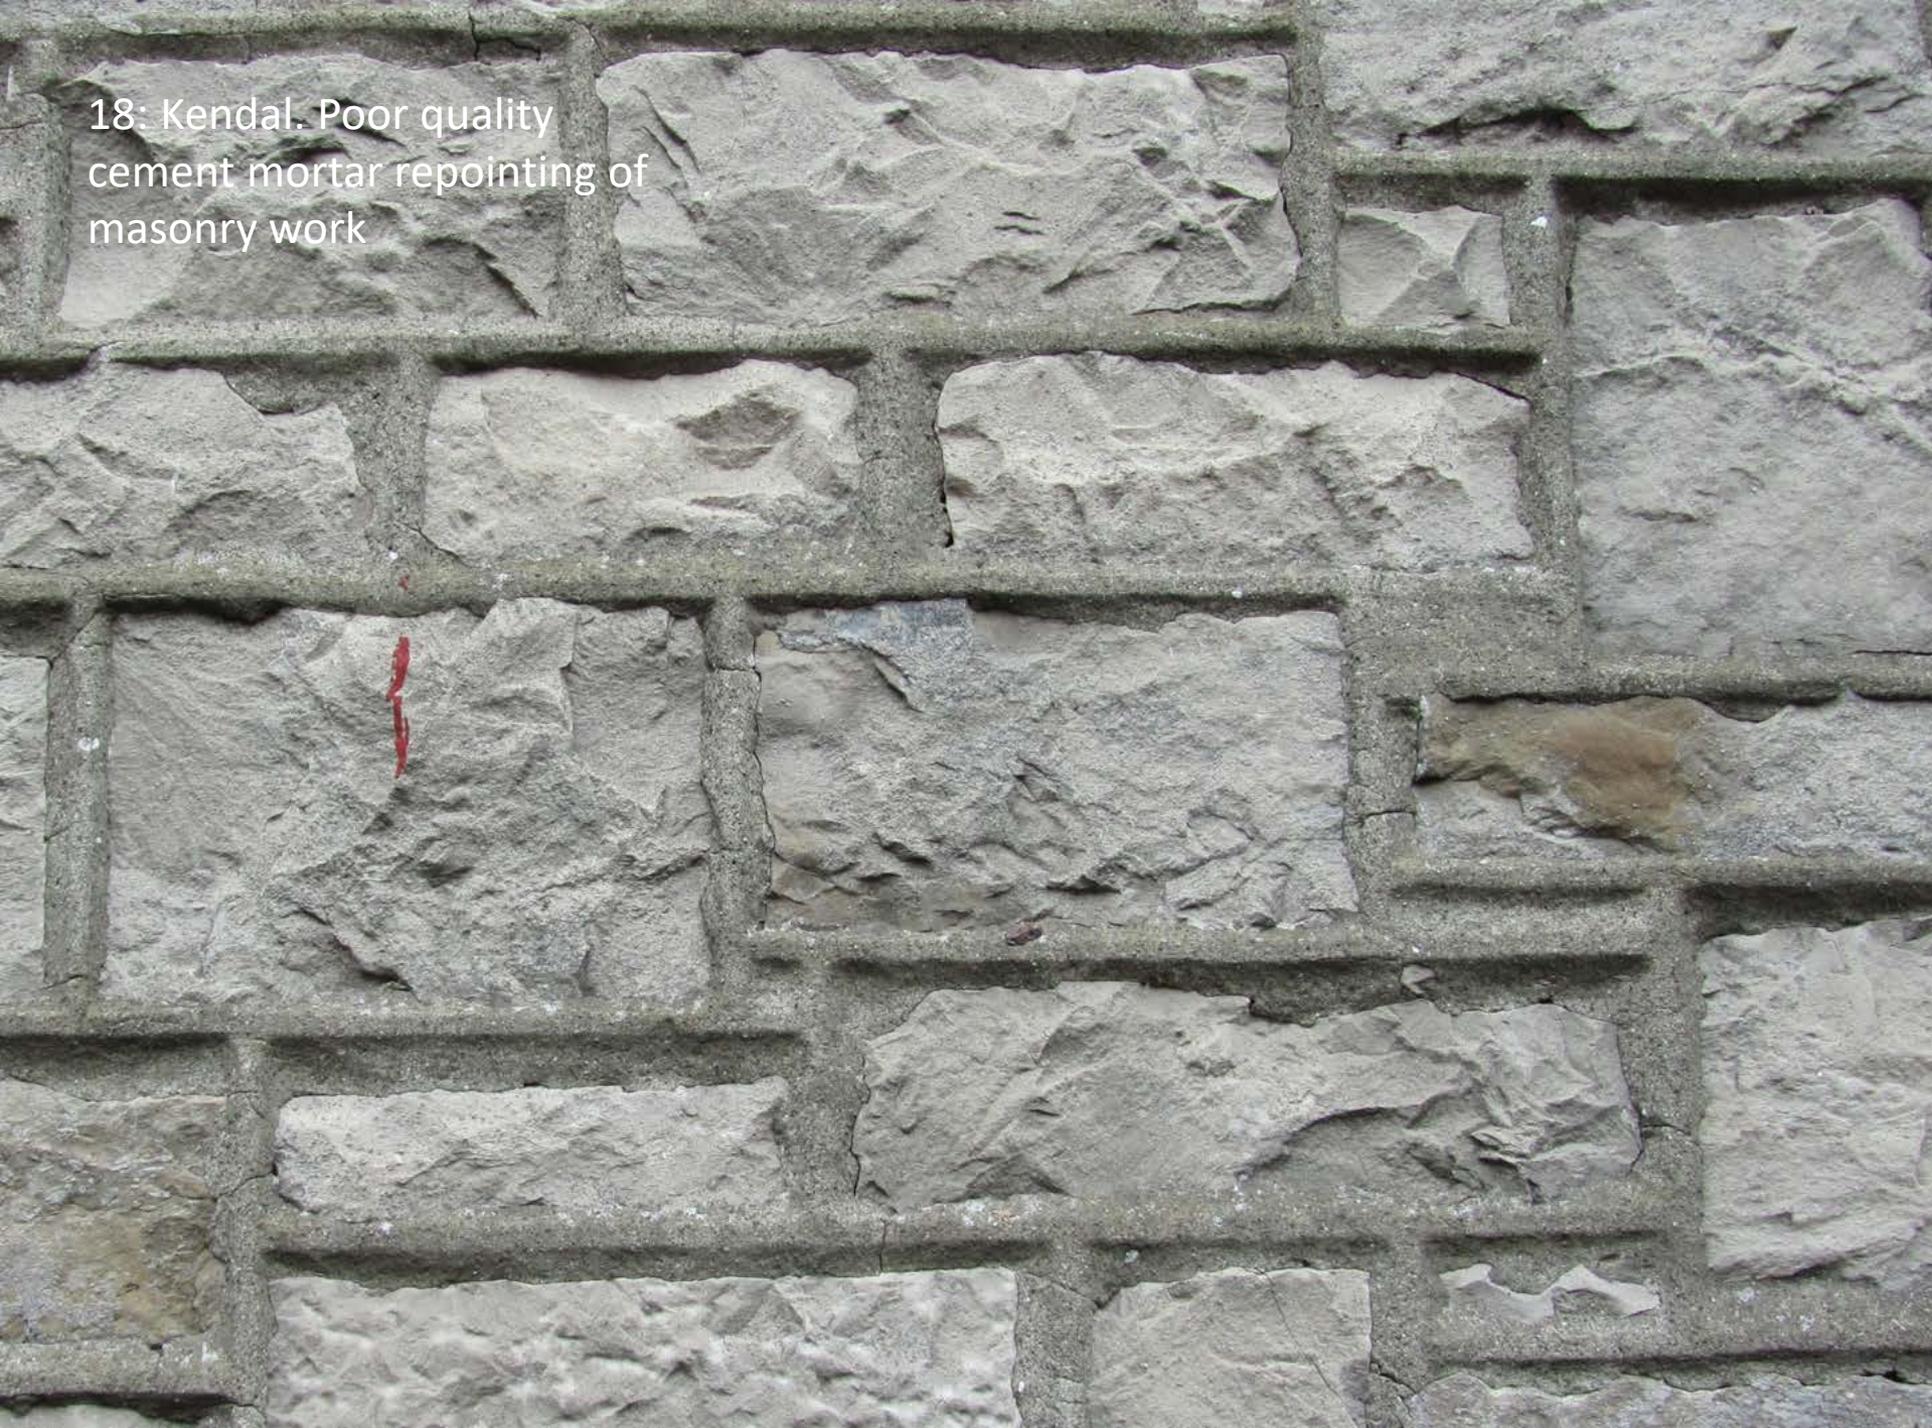
18: Kendal. Poor quality
cement mortar repointing of
masonry work
