Insight 1 Unit 3: Image Set

How does a building work?

The Insight Unit relates to the www.understandingconservation.org Unit3: Investigation, materials and technology to offer pointers as to how such investigations might be structured and what needs to be covered.

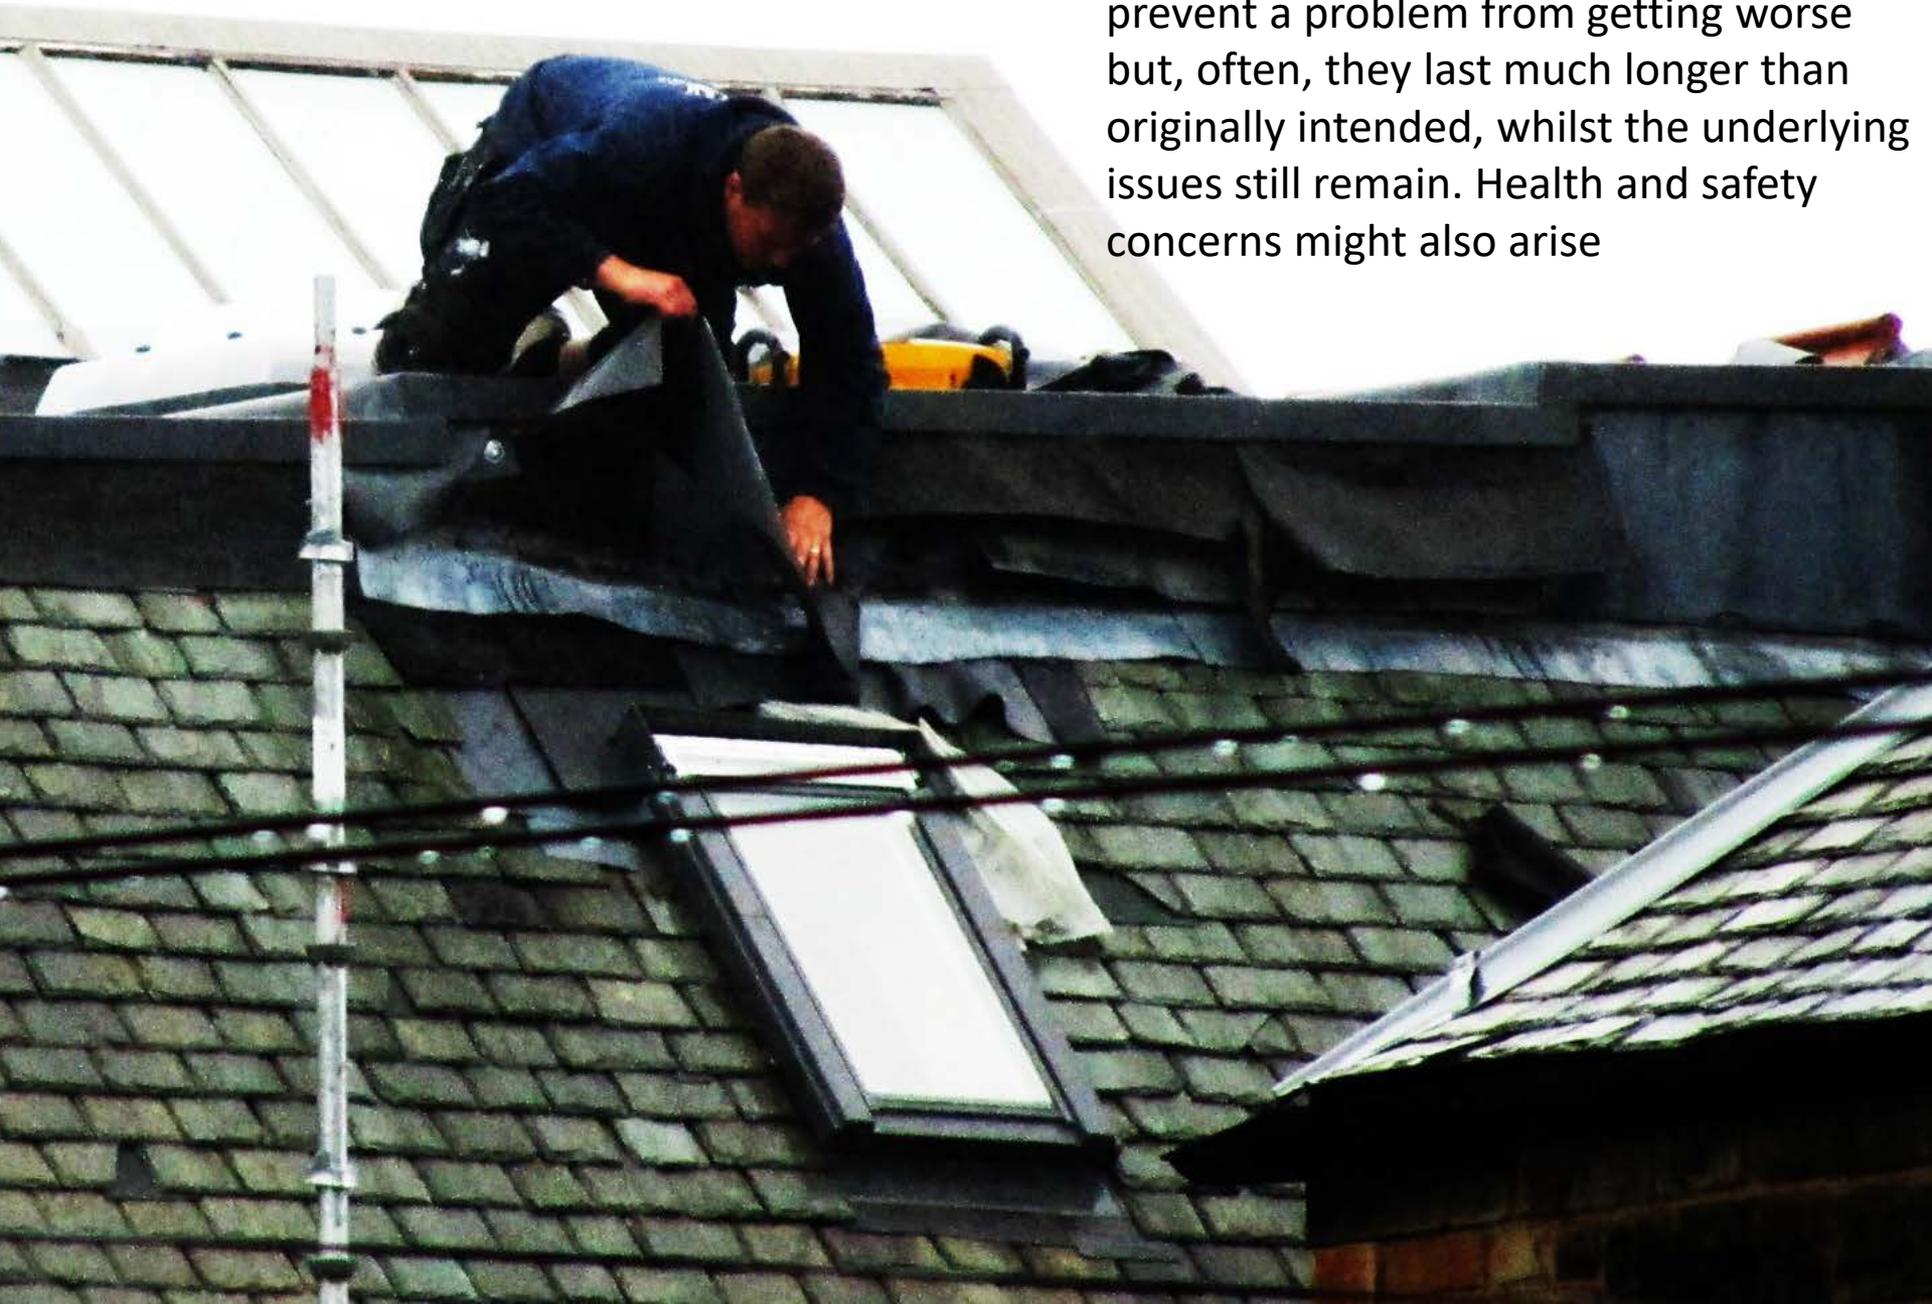
22: Newport. Temporary repairs can prevent a problem from getting worse but, often, they last much longer than originally intended, whilst the underlying issues still remain. Health and safety concerns might also arise

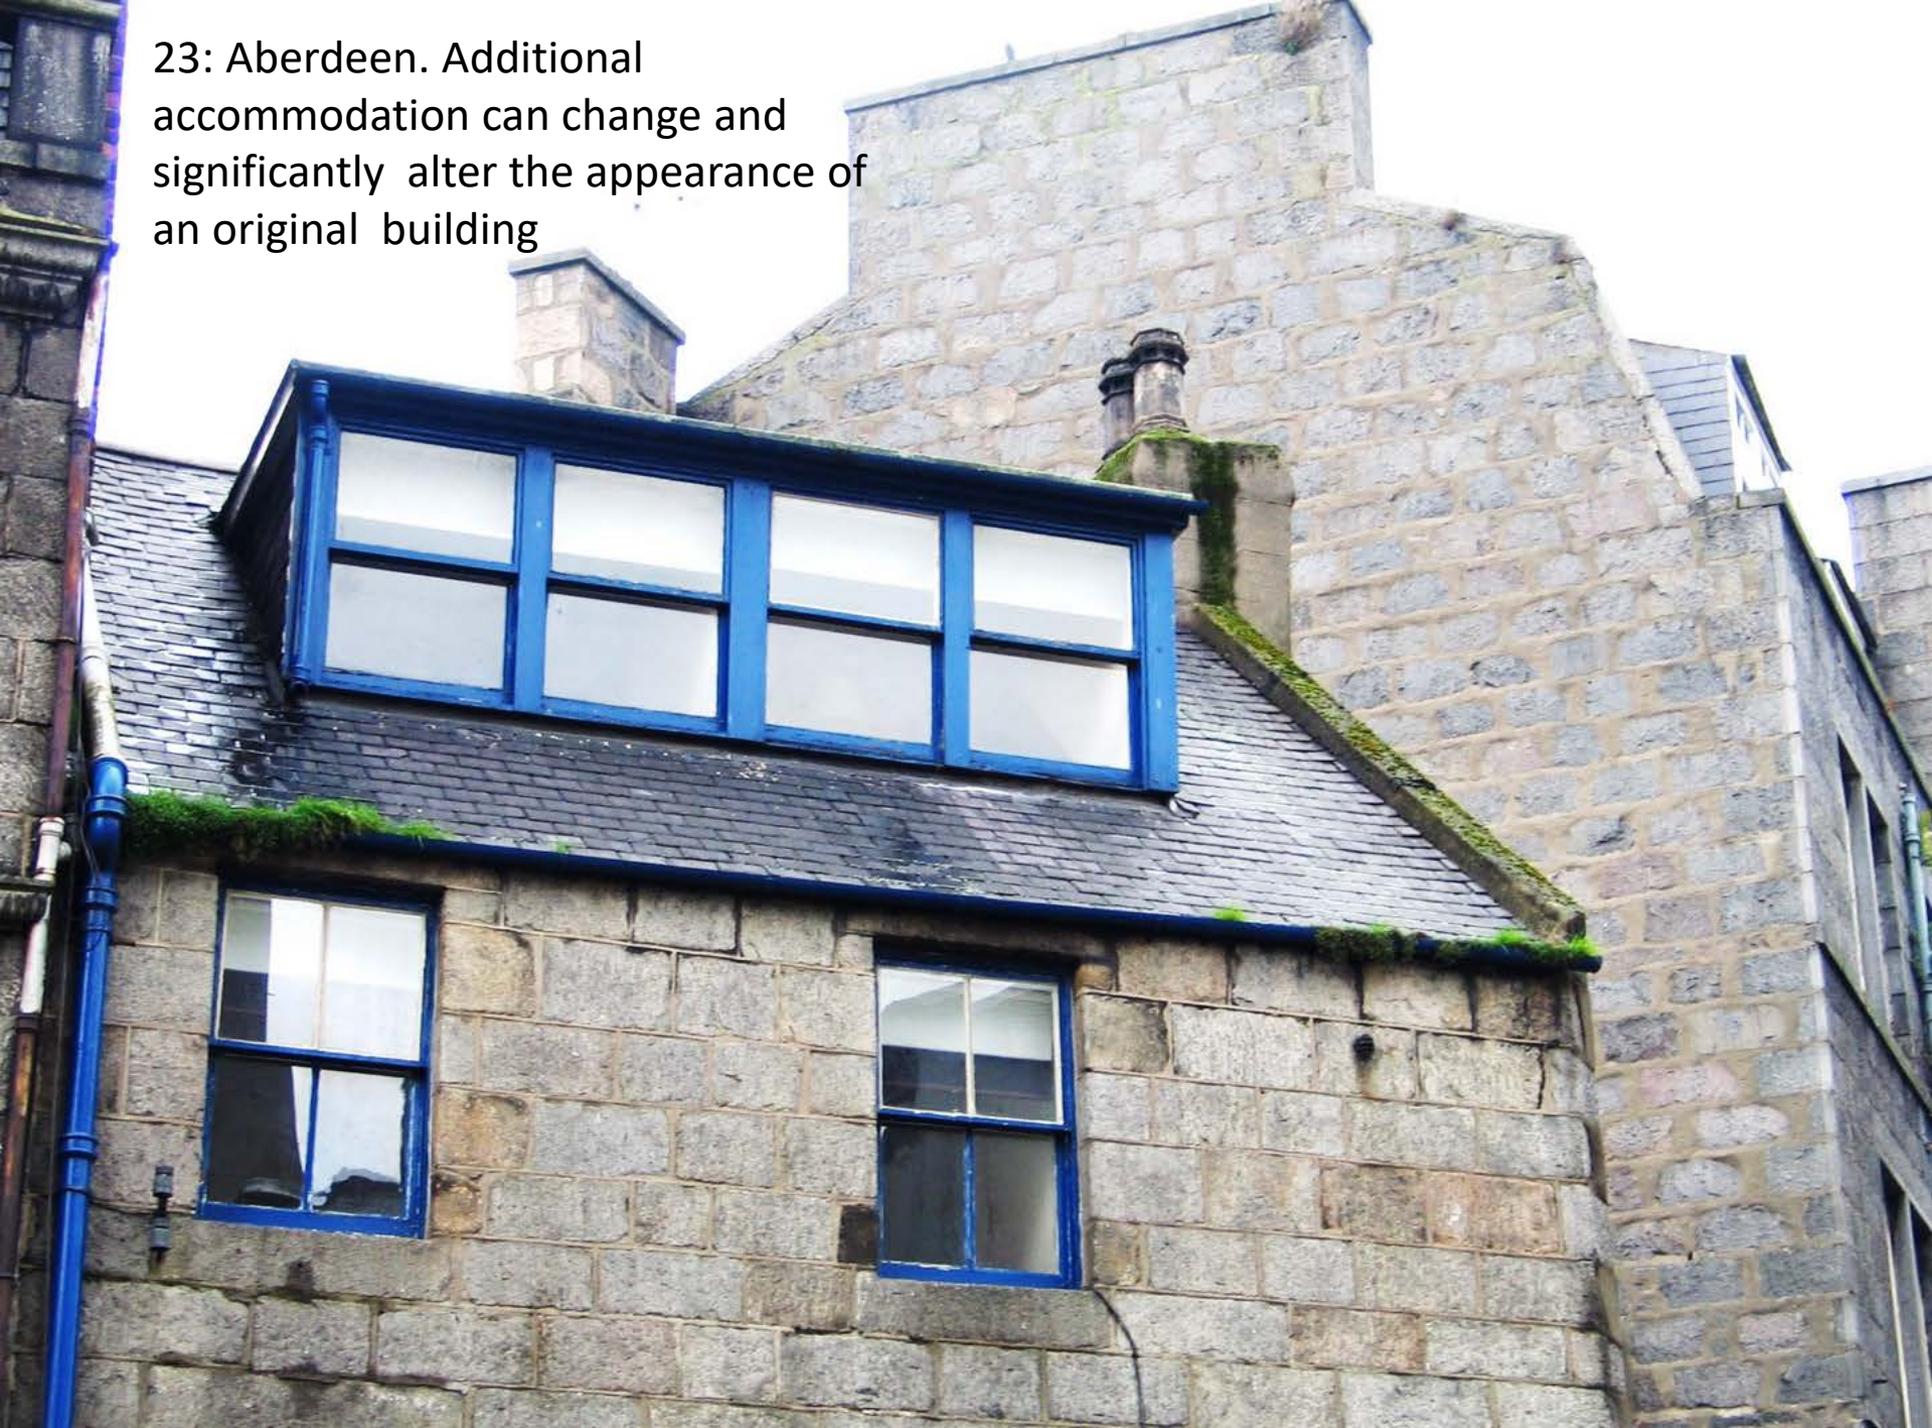
23: Aberdeen. Additional accommodation can change and significantly alter the appearance of an original building
