Geraldine O'Farrell

Vice chair – CIBSE Heritage Group

*The Challenge of Installing  
Building Services in Historic  
Buildings*

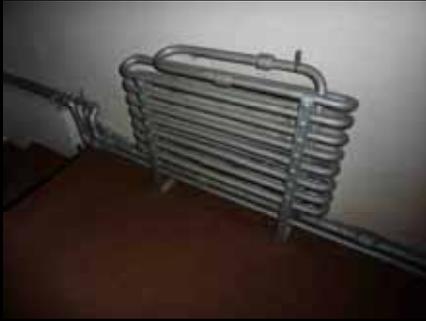
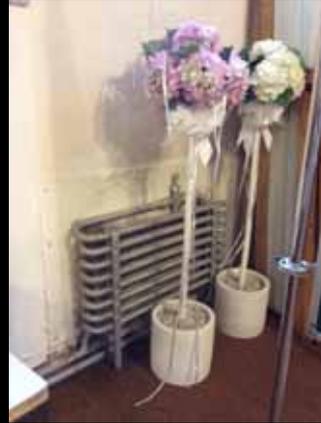
## Existing early systems can be put to good use

- The first church did not ask for advice from English Heritage or CIBSE Heritage Group
- The second church wanted to keep its heating system but needed it to perform more effectively
- The solution agreeable to all was very simply adding a better pump set, adding additional plain radiators and replacing some pipework and introducing a zoning system to the heating layout so that it could be controlled more effectively.
